**HIHI Inspections**  
HAWAII ISLAND HOME INSPECTIONS

**Inspection Address**  
Condo Building, unit 000  
12345 Island St.  
Hawaii County, HI

**Inspection Date**  
June 10, 2023  
3:00 pm

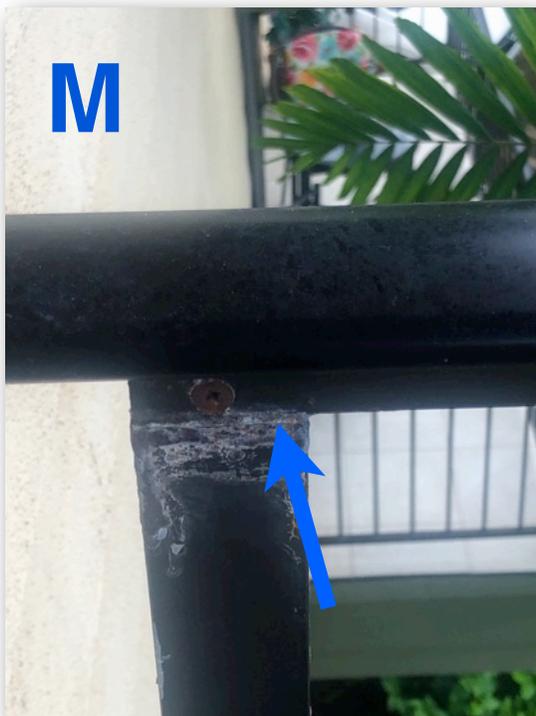
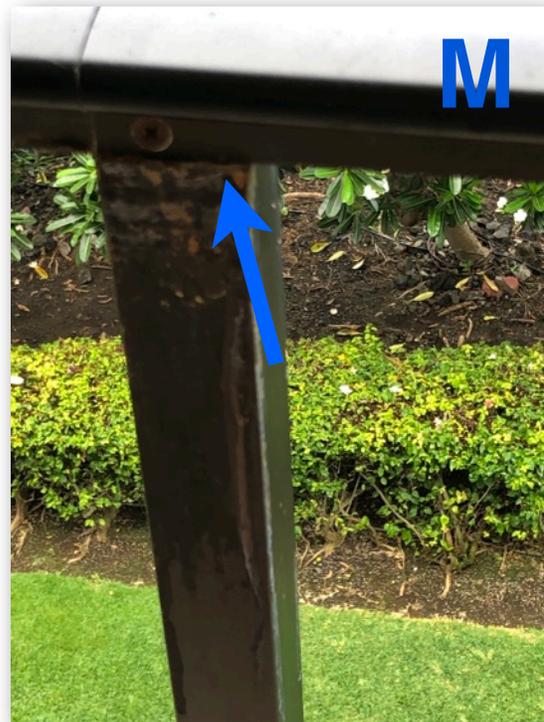
**Comments:** The overall condition of the lanai tile floor is noted to be in good condition. The aluminum railing has signs of corrosion at many of the joint fittings between rail and baluster. This is usually from moisture - especially salty on the coast - and age. This is labeled as a maintenance issue and not a safety issue as the railing itself is in satisfactory condition.

Areas of corrosion on railing

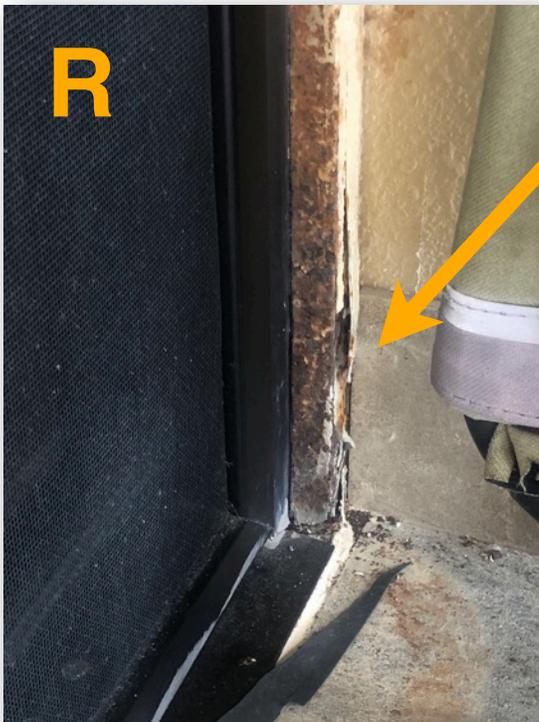
**Comments:** The overall condition of the wall covering in the lanai area is noted as satisfactory with the exception of the right slider trim - water has collected and seeped into the corner area causing the rusting and expansion of the metal trim bead. It could be that the lanai has poor slope drainage in this corner. Inspection for water damage below the unit was not possible at this time, however, water damage has occurred from this same issue on the interior which is covered in the Interior report section. I recommend evaluation and repair by a qualified handy person or carpenter.

Water damage to trim/wall

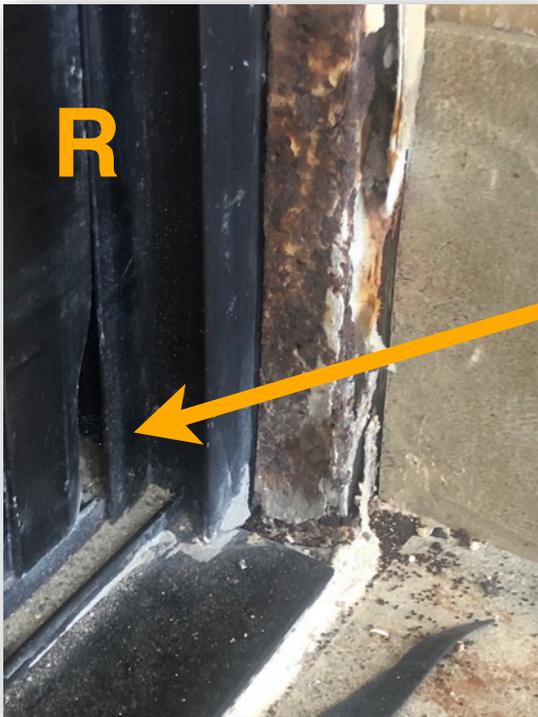
Corrosion of sliding door and frame - leaving a hole

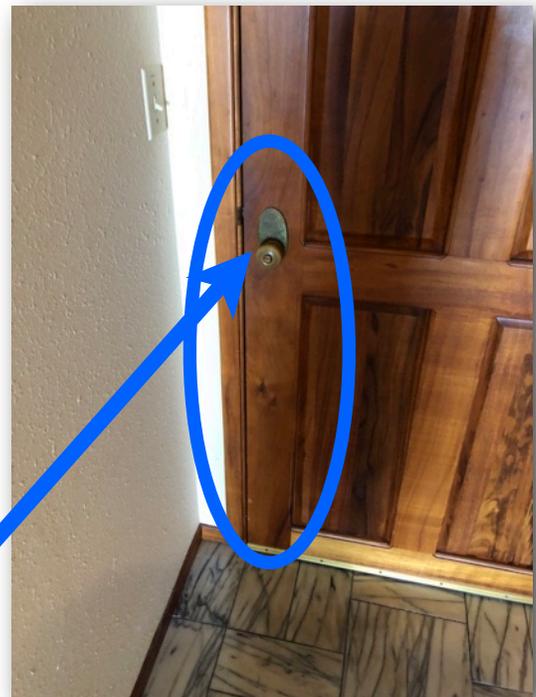
The wood **front entry** door has an inward warp in the lower half which causes the door to not properly seal. This is typical of custom wood doors. **Note:** The Entry Door's only security is a locking knob. I recommend a matching door deadbolt. The entry screen door's function is noted as satisfactory.

**Warp Area**

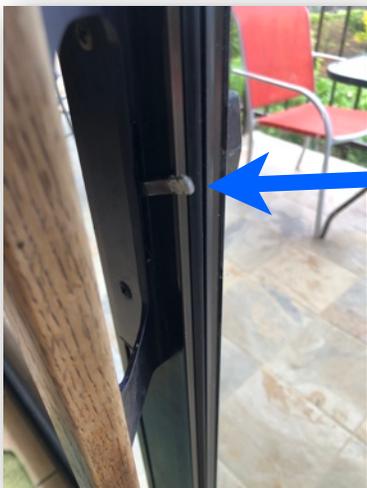
Missing grip on lever

Note: Locking knob only

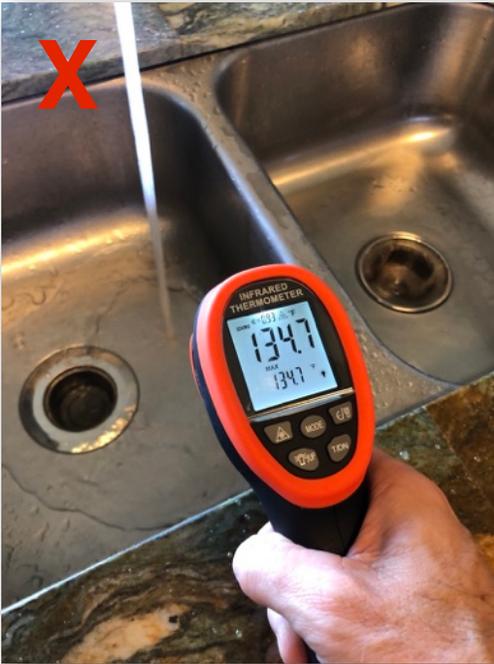
**X** The hot water temperature at the kitchen sink is 134°F. This is considered hazardous - contact for 15 seconds can produce a 3rd degree burn. Children and elderly are especially sensitive to this. The safety standard for scald prevention is a maximum 120°F. The temperature was not checked at other fixtures to determine if they incorporated updated anti-scald fixtures.

**X** Recommend a qualified plumber to further evaluate the settings on the hot water tank and whether a mixing valve should be installed on the hot water tank.

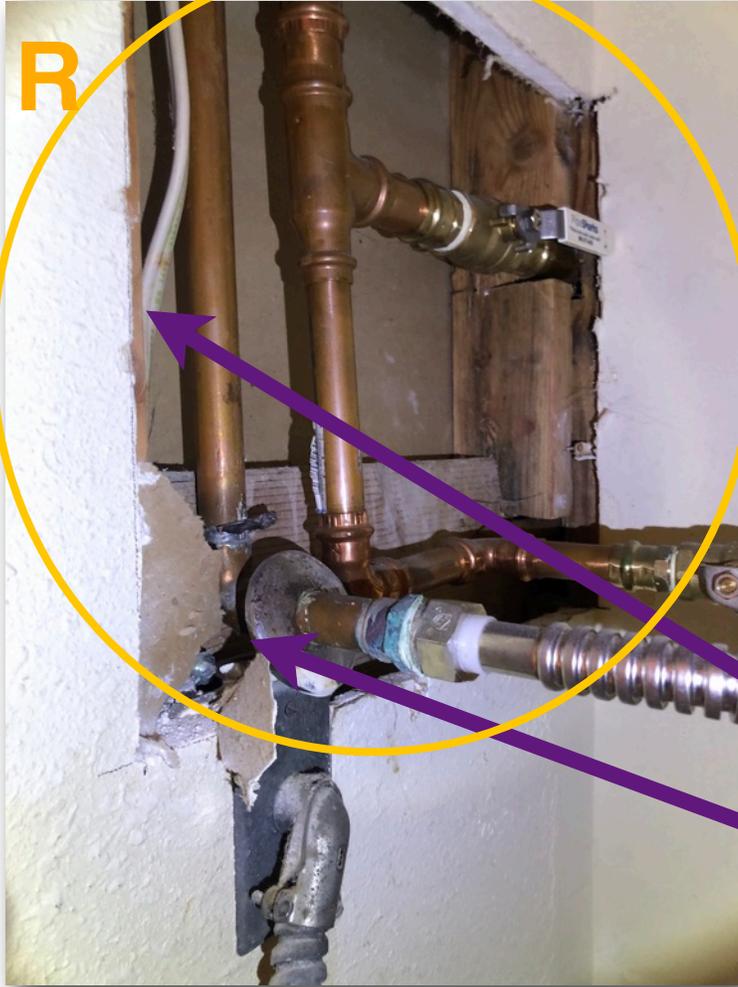
**Comments:** Repair/installation work area has been left open. The 240 volt NM wire is unsecured and contacting the copper water pipe. Also, the copper pipe is installed directly above the 240V junction box: Any water leaks, work done or condensation would drip directly onto the electric box. I recommend further evaluation and repair by a qualified professional.

Loose 240 volt wire and water pipe install over electric junction box. Recommend further evaluation from a qualified professional

Recommend the wall board be properly repaired or access panel be placed to block airflow and access to stud wall cavity.

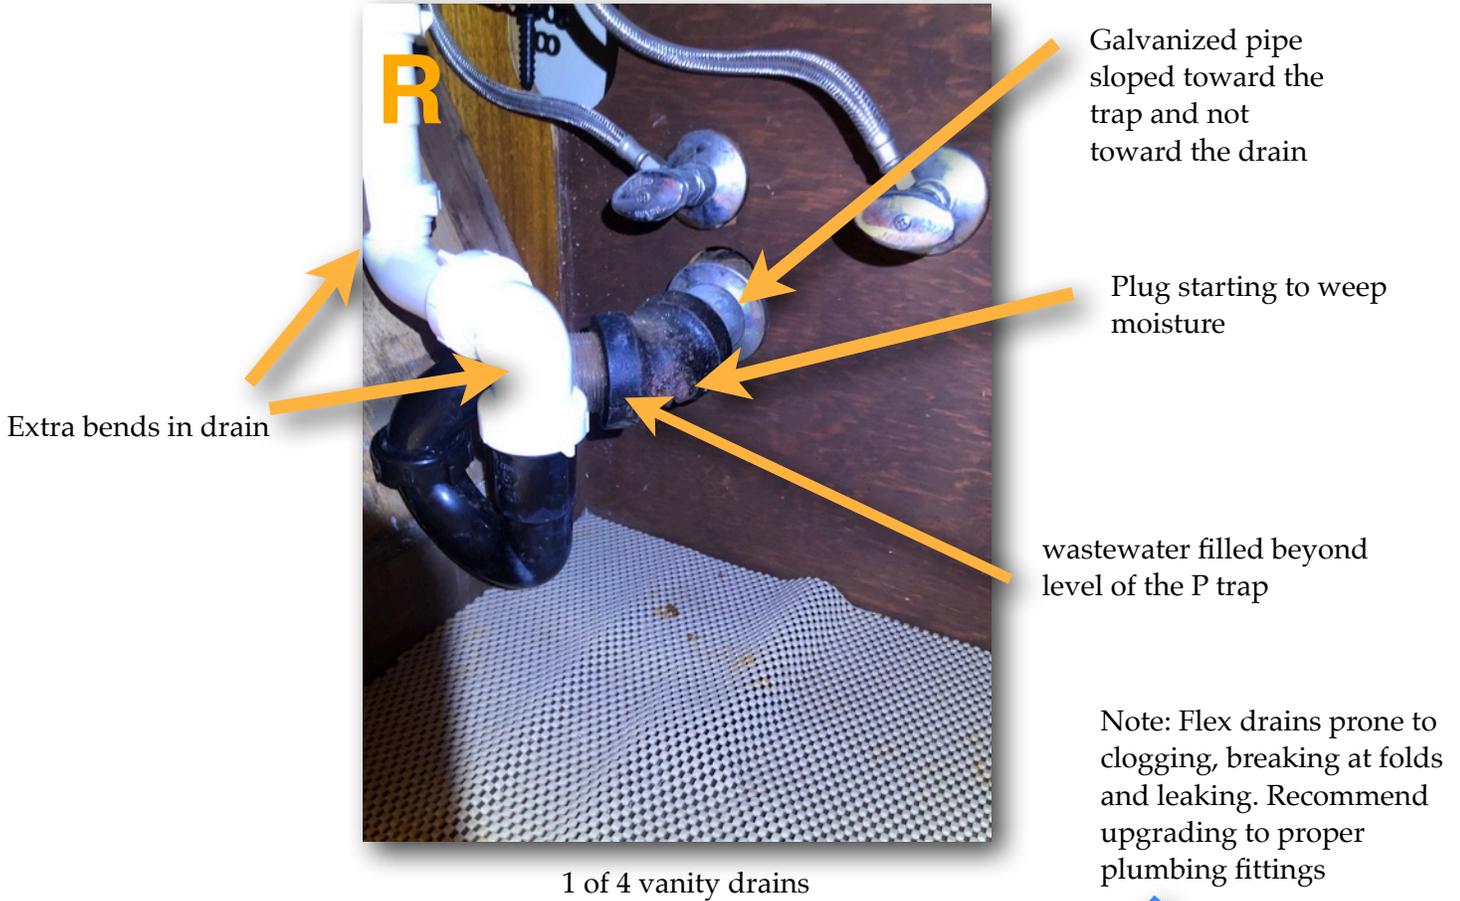
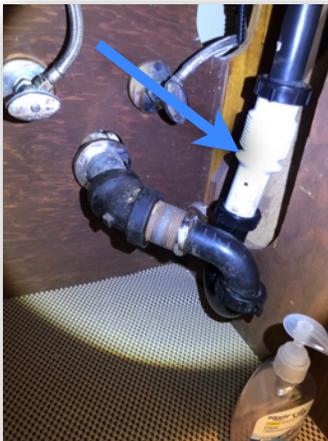
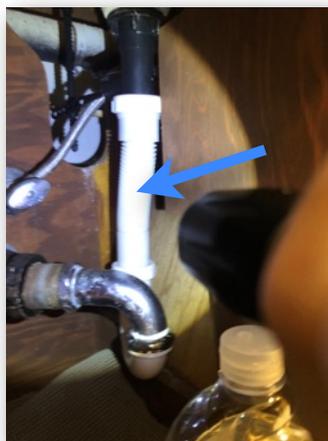
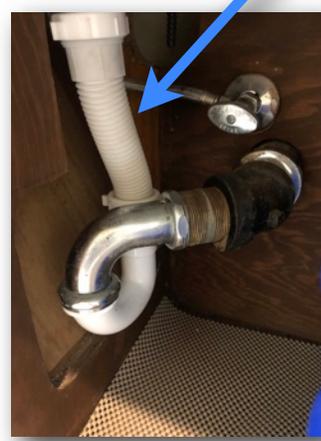
**Comments:** The two bathrooms have double vanity sinks. 3 of the 4 drains are plumbed incorrectly. The vanity traps and drains are below the entrance to the stack - they slope toward the trap and not away. This is an improper, contaminating installation. This means that there is waste water in the pipe above the trap - essentially the entire P trap is filled at all times and effluent from upper floors can possibly enter the trap. One cast iron fitting's plug is badly corroded and starting to weep wastewater. The plywood wall plate and water damage on the vanity woodwork also indicates that this is an ongoing issue. **I recommend further evaluation for repair by a licensed or qualified plumber.**

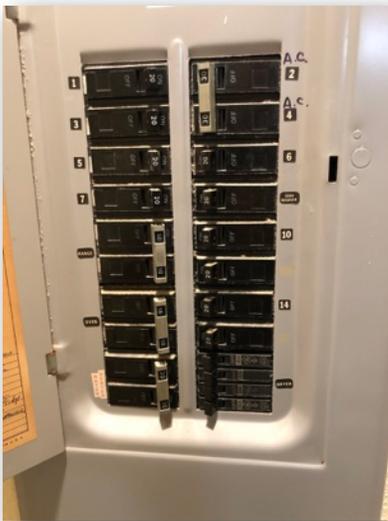
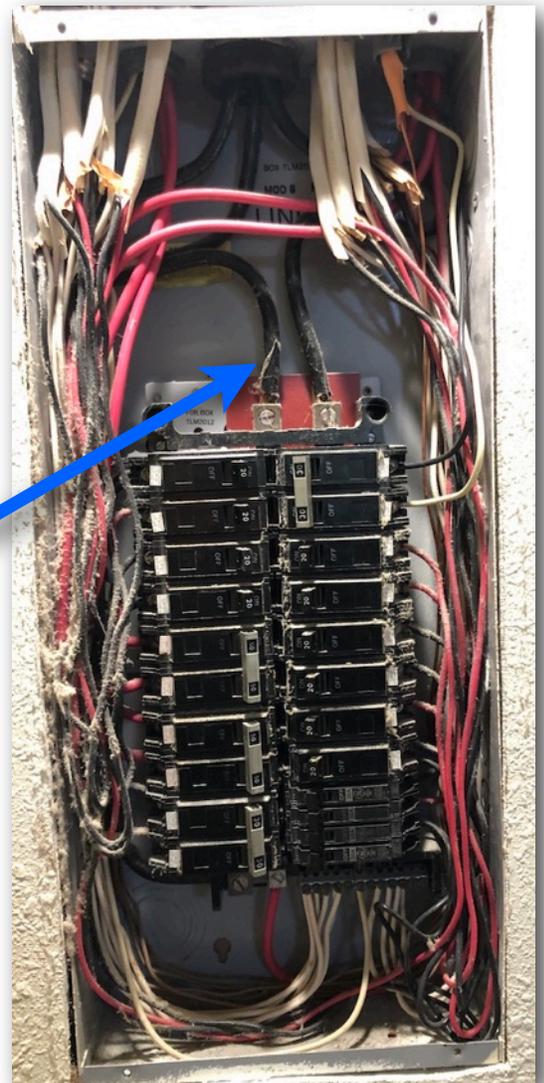
No Sub Panel Disconnect Breaker

Recommend that the Sub Panel have further evaluation by a licensed electrician for a safety upgrade.

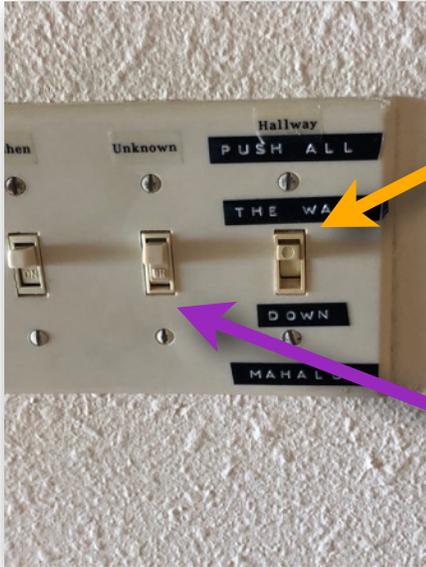
Dimmer Switch for hallway not functioning properly or improper bulbs in place

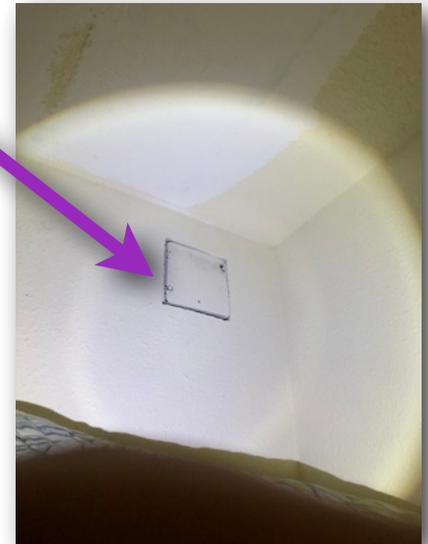
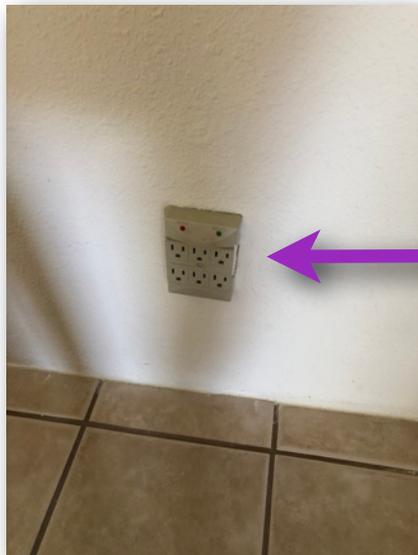
Aftermarket plug-in outlet over a removed outlet plate. Unknown.

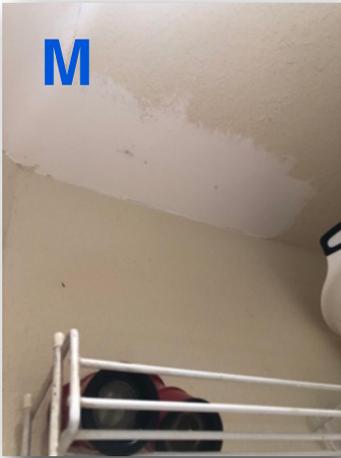
**Comments:** The overall condition of accessible walls and ceilings was satisfactory with typical wear with the exception of the bar ceiling, both bedroom closet ceilings. The AC installation has left these ceilings with new wall board but unsanded and unpainted. [Recommend finishing and sealing.](#)

Unsanded Drywall for AC install

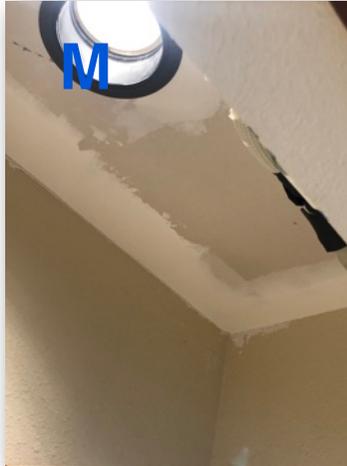
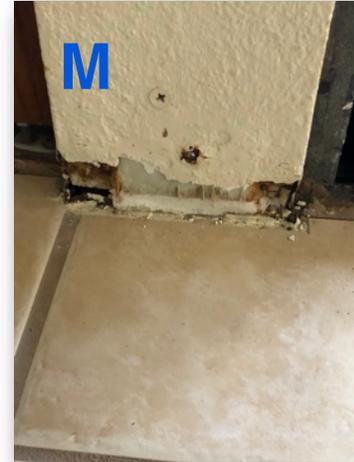
Water Damage from Lanai damage

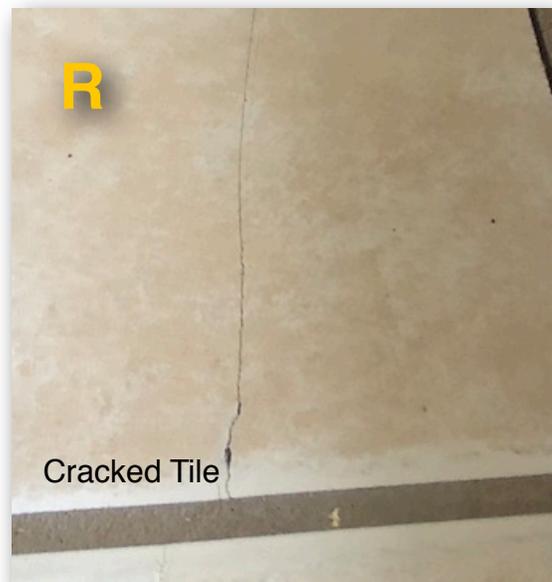
1. Spot-battered tiles easily crack if anything drops on them or if they are point loaded.
2. Edges at Tile/Wall joint have random patch areas and some areas are crumbling. Some patches are grout and some are caulk. Gaps allow easy access and highways for insects. [Recommend filling and sealing all floor edges.](#)

Cracked Tile

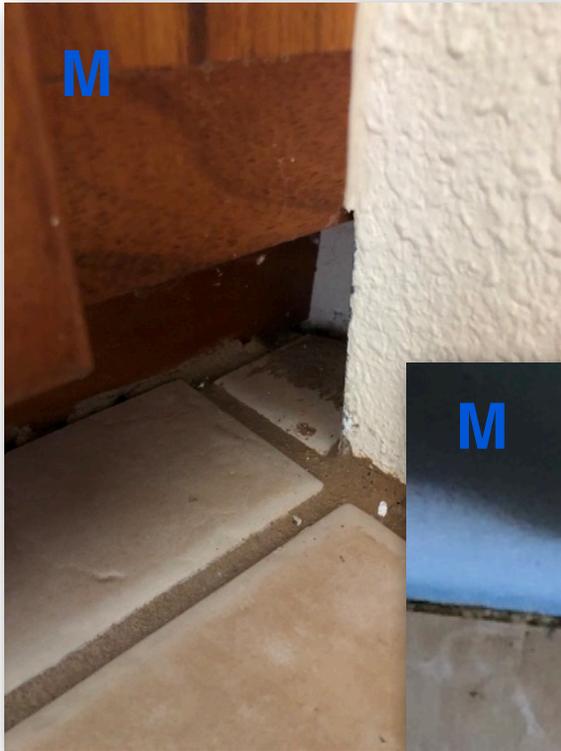
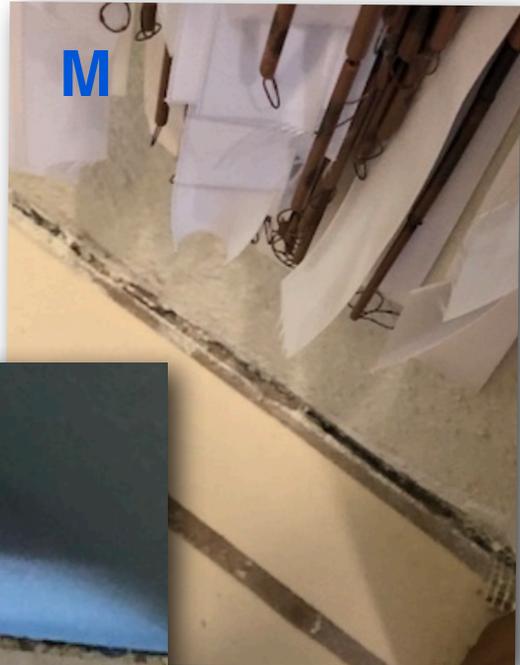
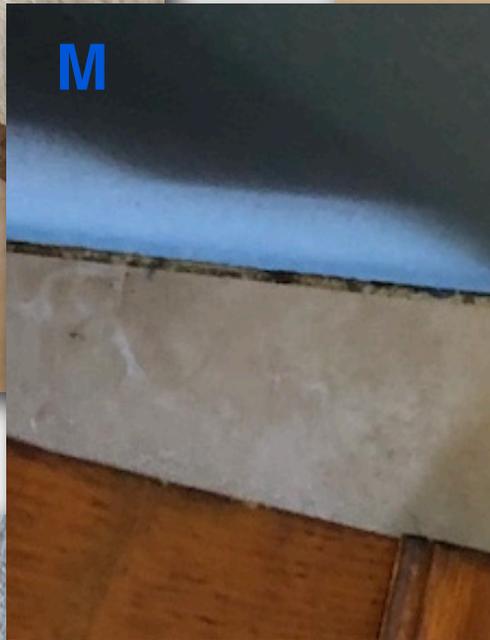
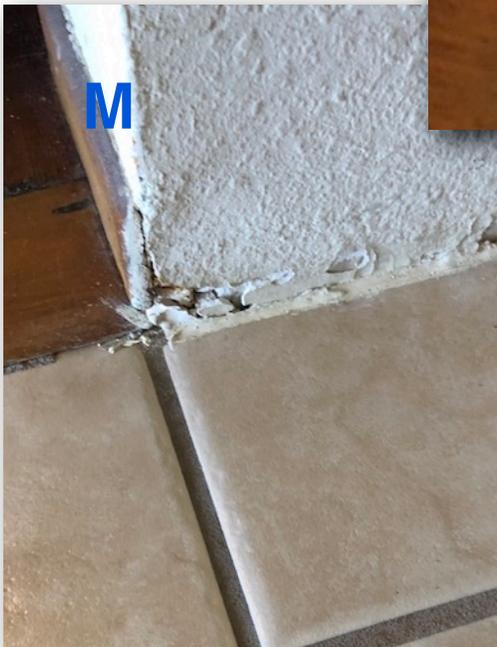
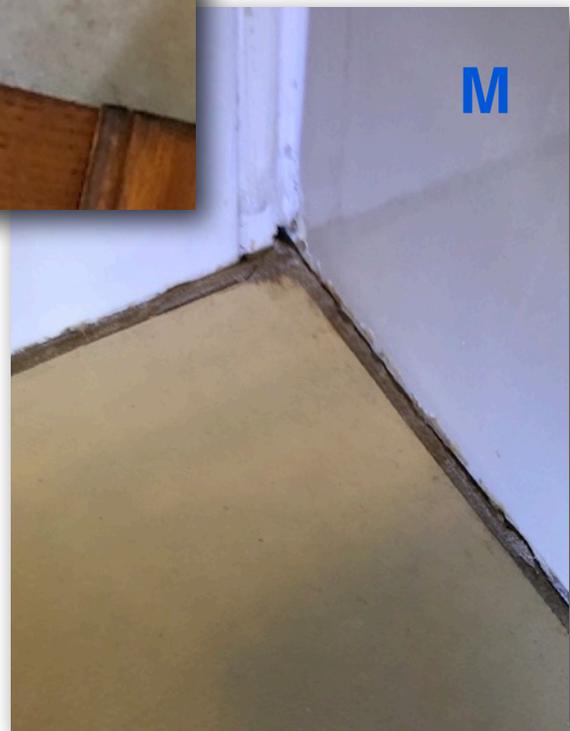
**Floor and Wall Edges - Recommend Maintenance**

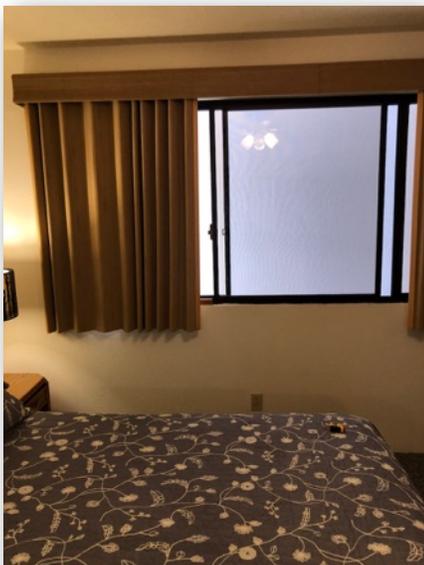
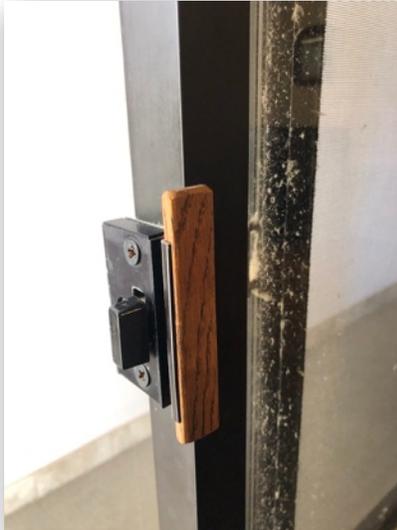
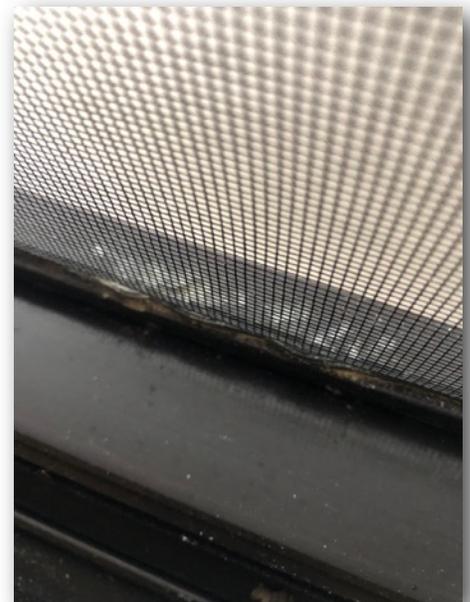
**Comments:** The overall condition of accessible windows was **Poor**. The Locking mechanism of the Guest Bedroom was hardly functional and the master bedroom window lock was non-functional - the catch being bent-in. There were lengths of wood to lay in the track to prevent access from the outside hallway. The Master Bedroom sliding window was not sliding and aligning correctly in the track. The Frames and the screens had areas of corrosion. The windows are past their useful and functional life. From a security standpoint and a functional standpoint, **I recommend that the master bedroom window be replaced and the lock repaired on the guest bedroom window.**

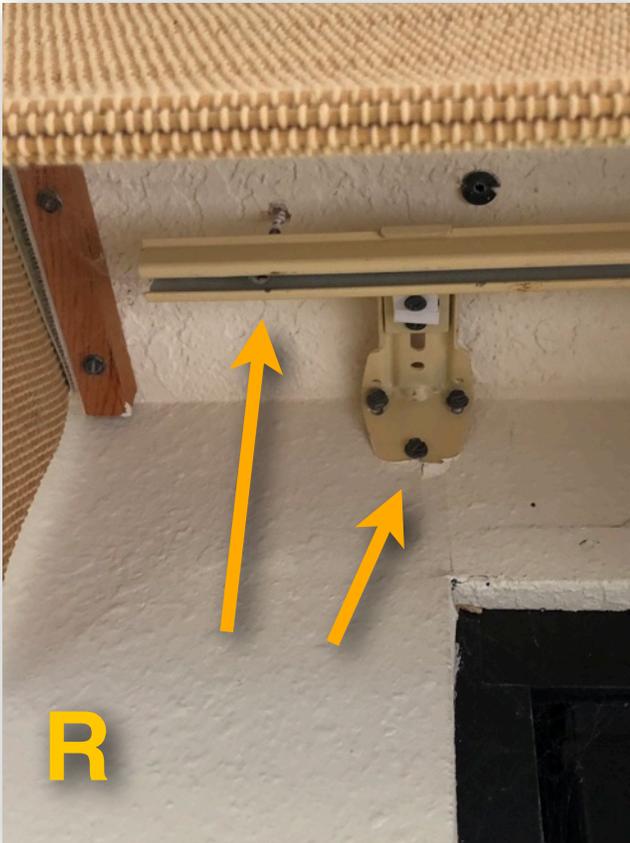
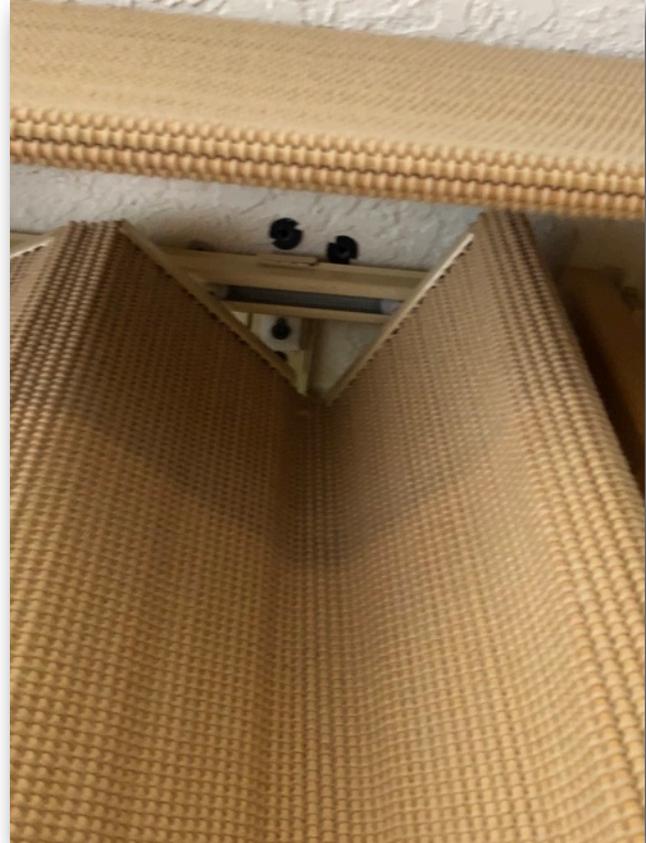
**Comments:** The overall condition of the blinds was noted as **Satisfactory**, with the exception of the right side track of the blinds servicing the **lanai slider** had evidence of repeated and unsuccessful attempts to secure the track. The weight of the blinds being the culprit for pulling out the fasteners. **Recommend Repair with a more secure method of fastening.**

**Fasteners pulling out of ceiling and wall**

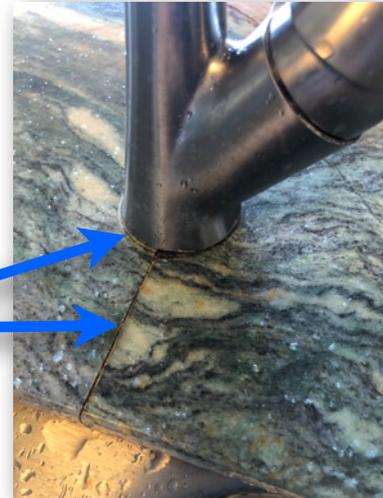
Maintenance:  
Reseal

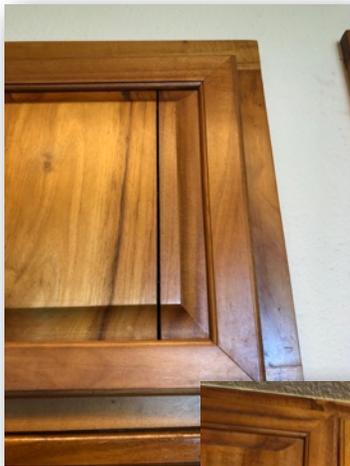
Cracking

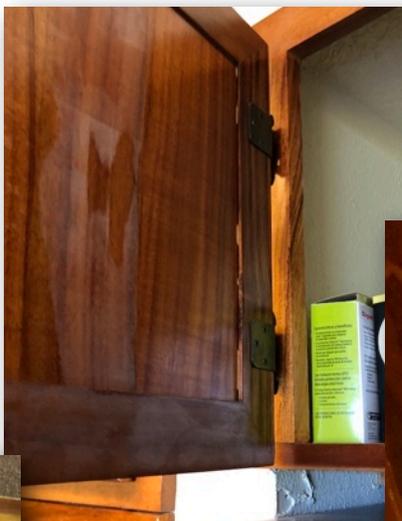
surface deterioration

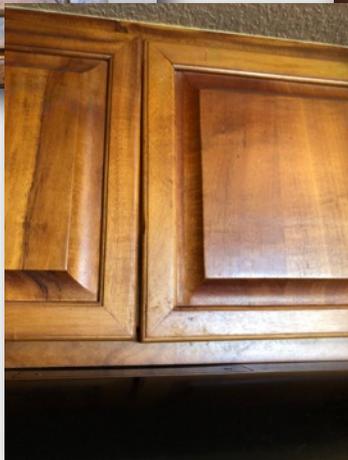
sagging

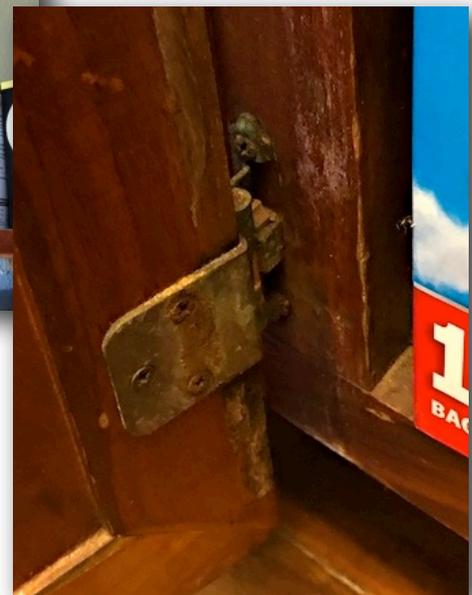
corrosion

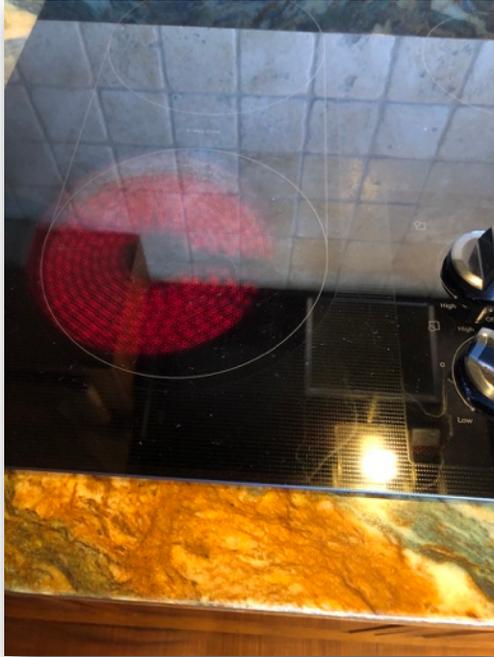
The left front range burner is functioning, but is offset by inches under the rangetop glass. It's unclear whether this is a manufacturing defect or a usage/installation defect where the element has shifted.

Recommend further evaluation by appliance specialist.

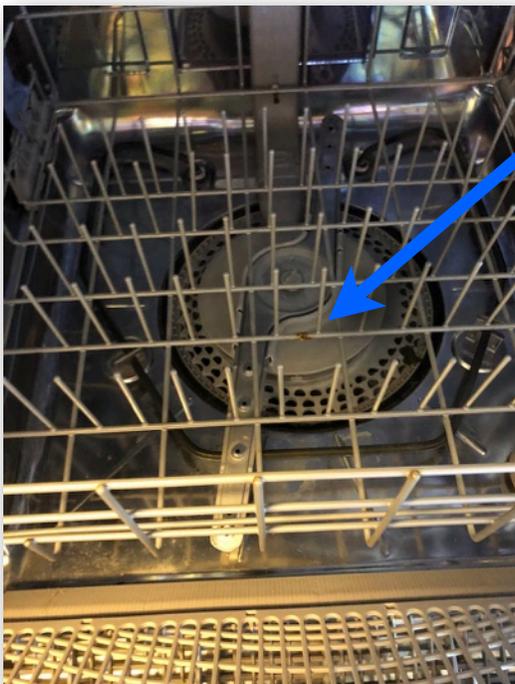
Small Rust Defect in Rack

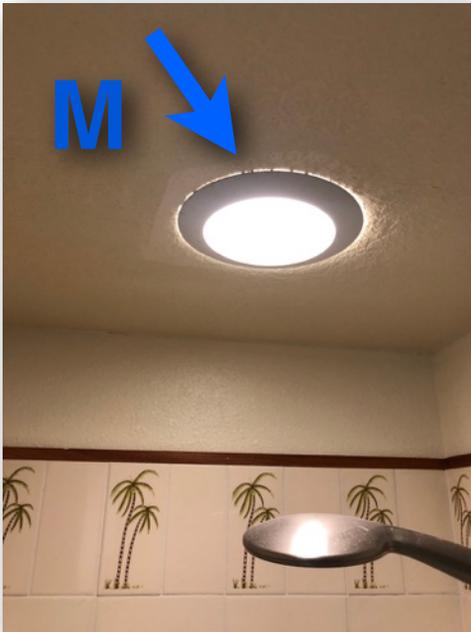
Shower Stall Light fixtures should be sealed against moisture

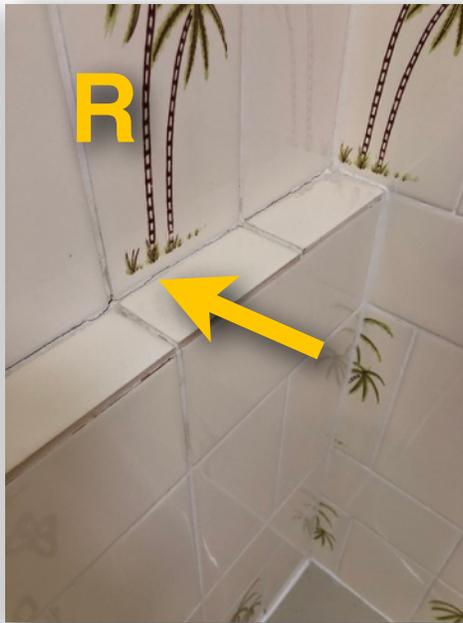
Cracked grout and back sloped tile allows water to pass behind

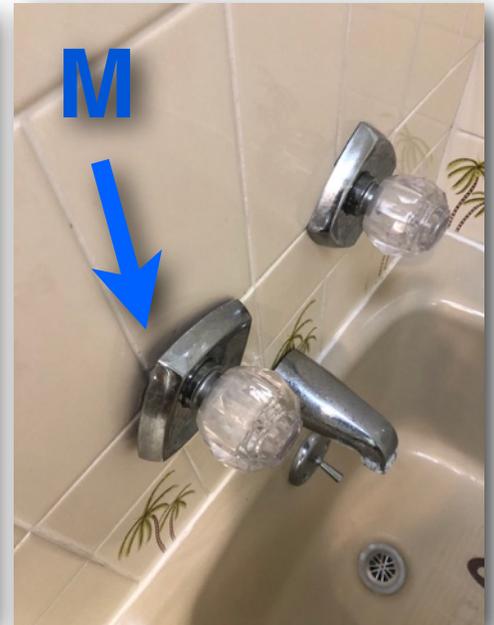
Tub trim loose and unsealed allows water to pass behind wall

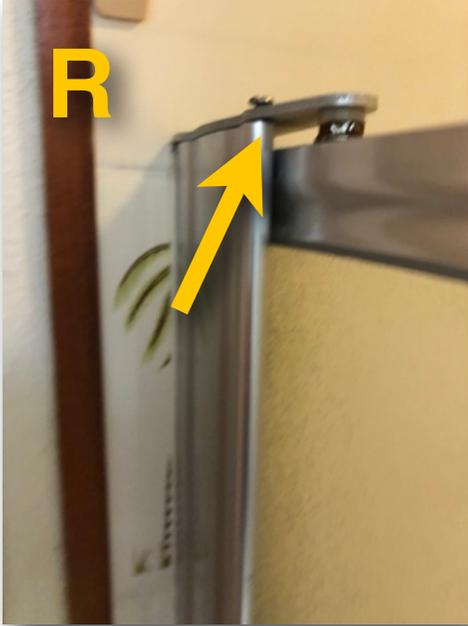
Shower Stall Glass Door loose on hinge - should be secured to prevent door from falling

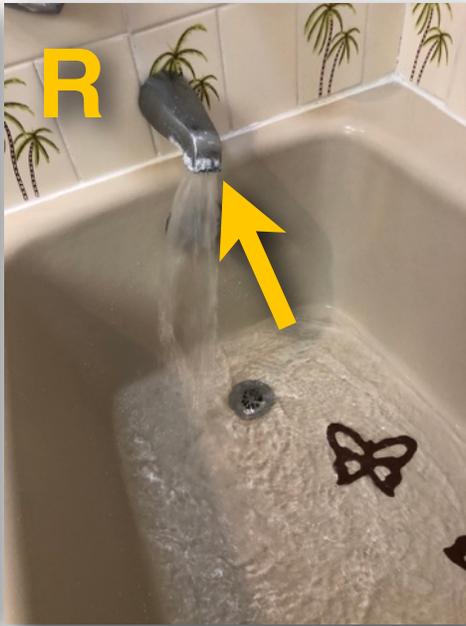
Tub Spigot heavily corroded, unsealed against tile wall and sideways

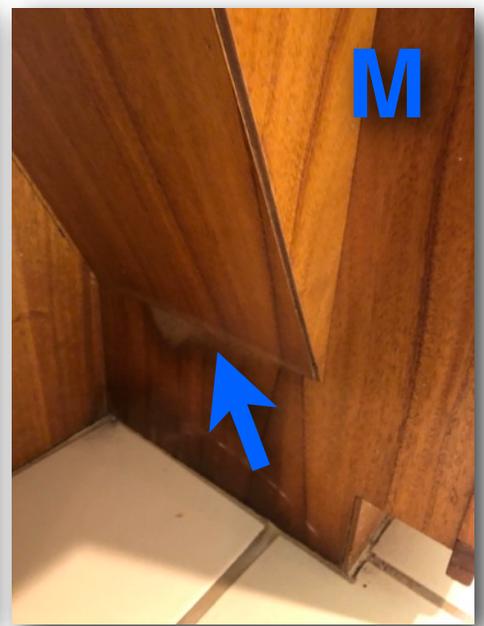
Water Damage from vanity trap. SEE PLUMBING SECTION

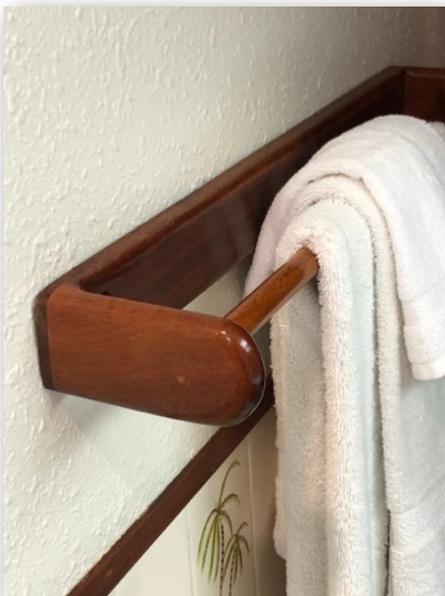
Towel Rack loose on wall

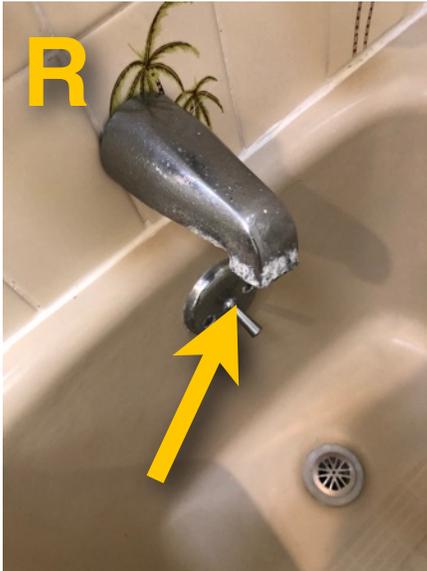
Tub Spigot heavily corroded, unsealed against tile wall

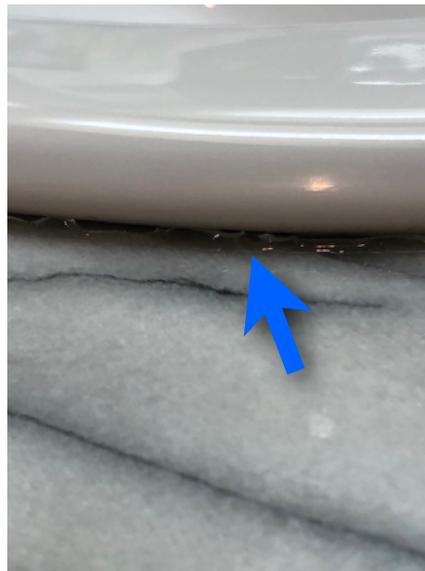
New vanity sinks - caulking seal has shrunk, pulled away with large gaps

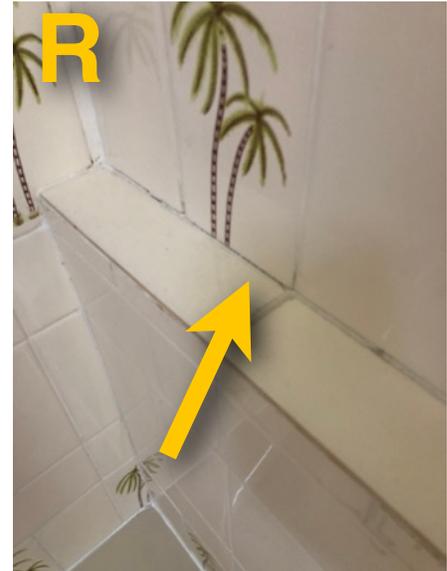
Cracked grout and back sloped tile allows water to pass behind

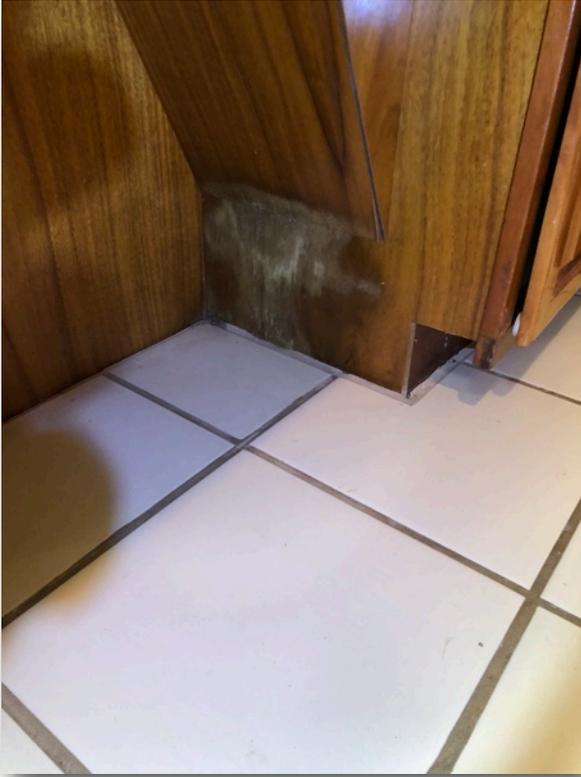
Water Damage from vanity trap. SEE PLUMBING SECTION

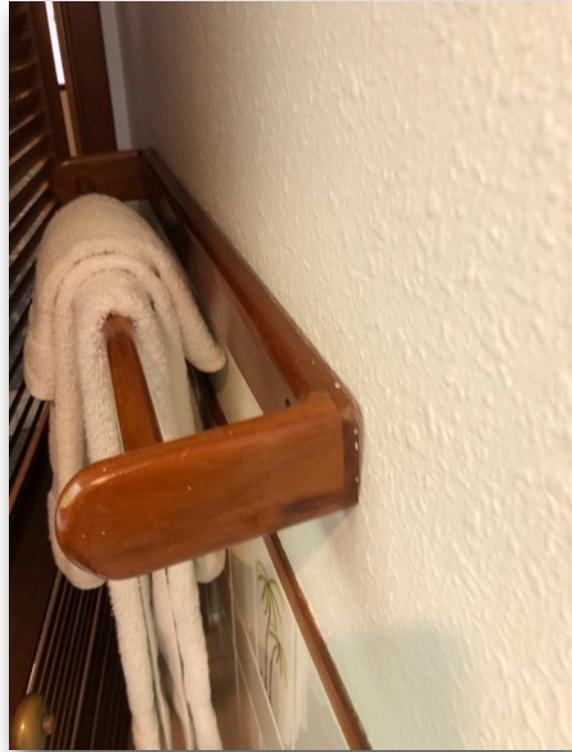
Towel Rack loose on wall

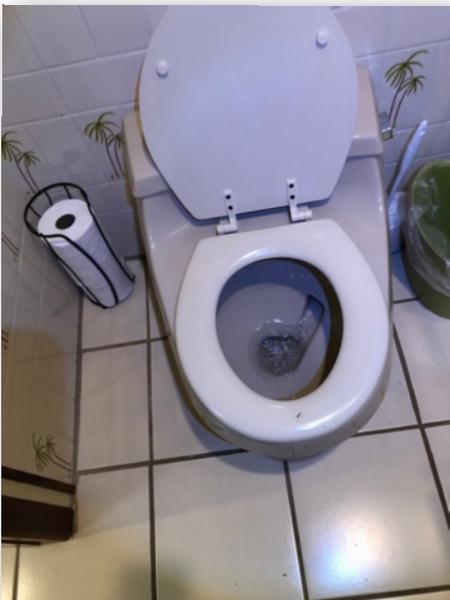
Slow to flush toilet with low vacuum

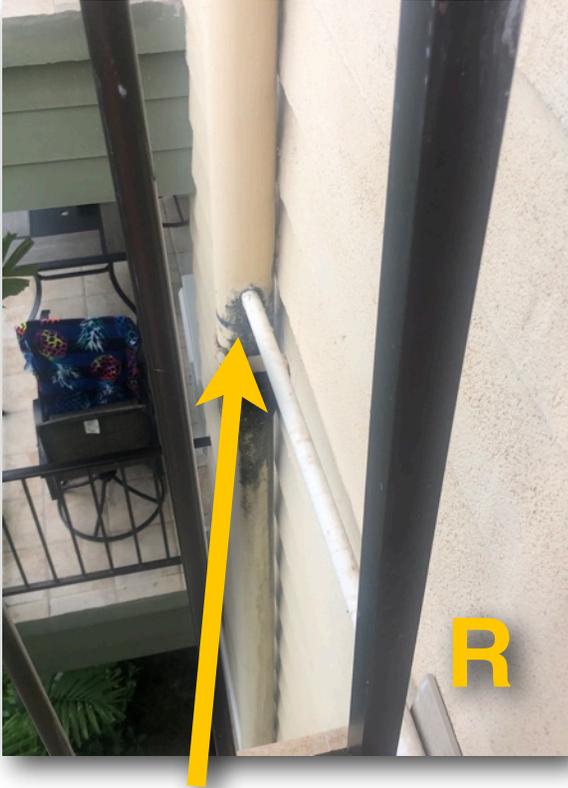
The units AC drain is piped into a shared exterior drain on the side of the building. The junction of the two drains is poorly installed (basically, a hole in the pipe) and drainage from upper floors is leaking from the junction. Also, there is no visible or accessible trap or vent observed in the pipe from the AC Condenser/Compressor.

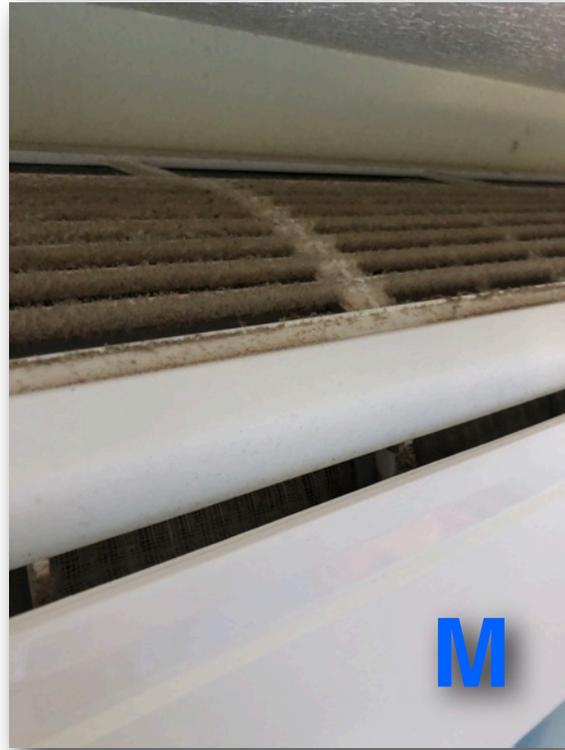
The top of each wall unit requires cleaning for efficiency.
