**HIHI Inspections**  
HAWAII ISLAND HOME INSPECTIONS

**Inspection Address**  
12-12345 Street St.  
Hawaii Town, HI 96000

**Inspection Date**  
May 24, 2023  
10:00 am

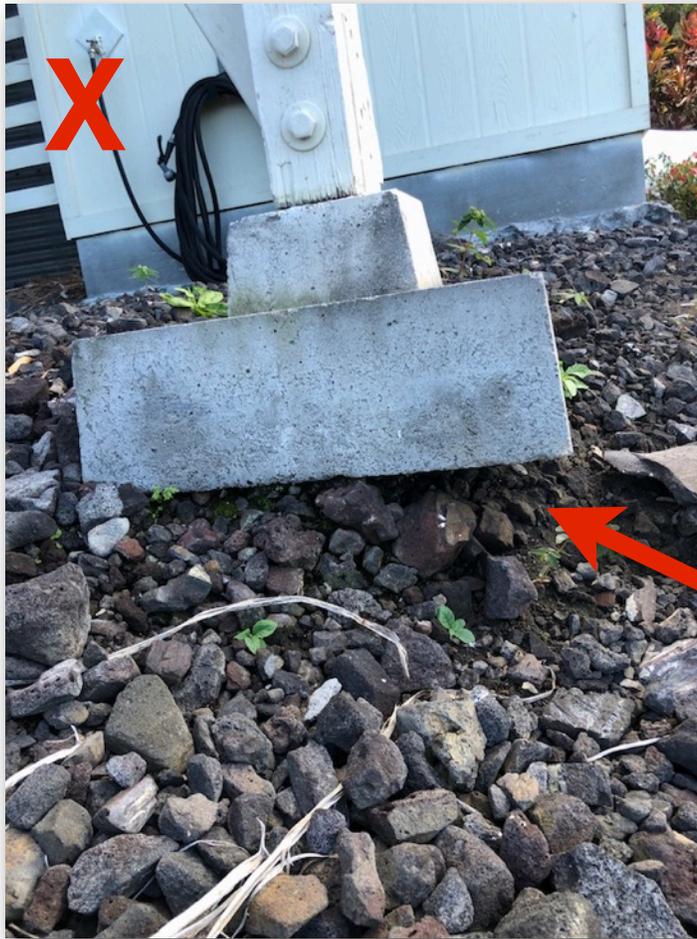
The south-west lanai pier footing is in need of support due to erosion and settling. The solidity of structure supporting the lanai will be compromised if this is not repaired.

Loss of pier block support

I recommend further review by a concrete / foundation professional or a qualified mason.

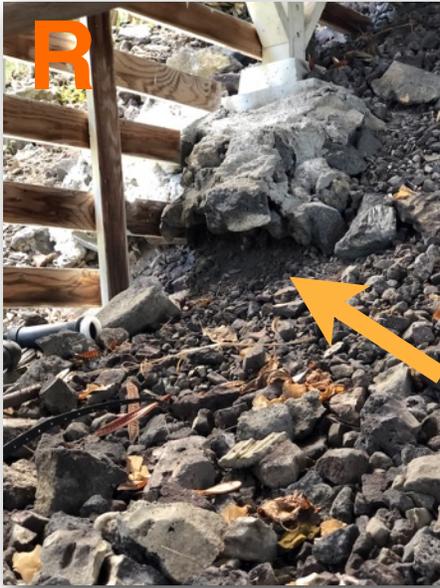
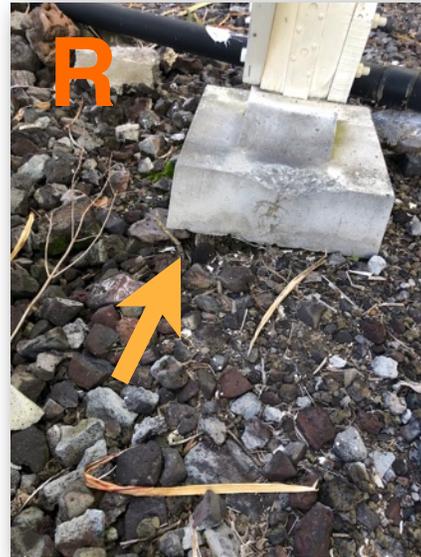
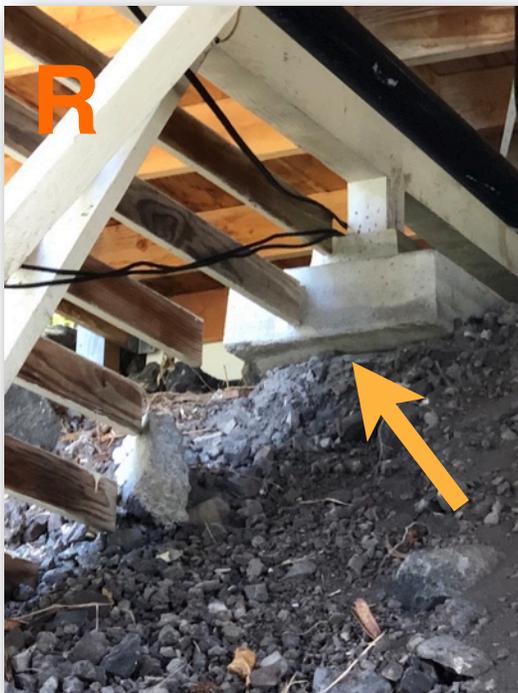
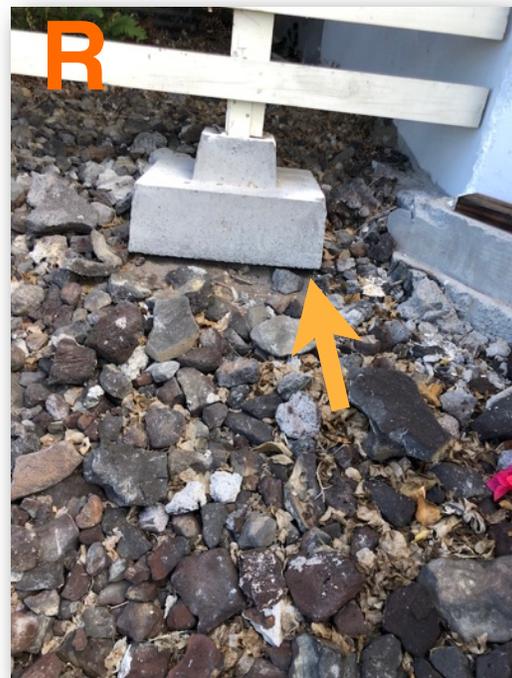
Several other piers/footings have undercutting of base fill material due to normal settling, vibration and water/gravity erosion, but they are not as critical as the lanai pier block. This is common for homes in Kona Paradise due to the dusty, round-rolling nature of lava rock fill and the steep slope. Human activity around the edges and lack of rooted vegetation also have cause. This erosion has happened over a long period, but it's getting to the point where movement may occur if a repair is not made soon.

I recommend further review by a concrete/foundation professional or a qualified mason.

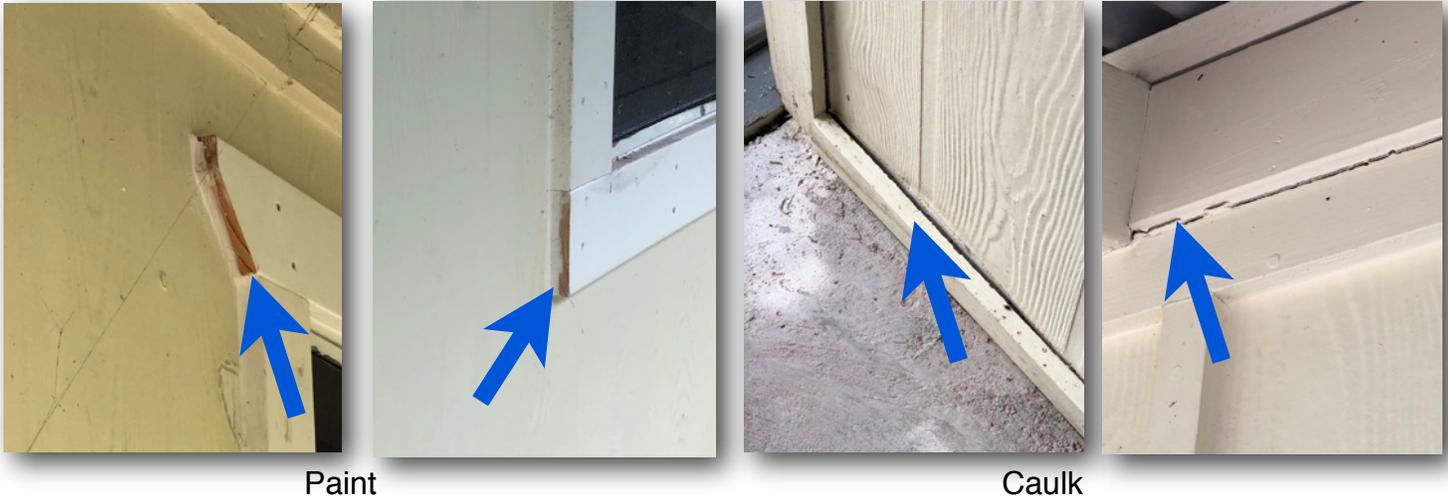
**Description:** Wood textured Hardie board - fibrous cement sheathing. Trim is painted and sealed wood.  
**Comments:** Siding and trim is noted to be in good condition with typical wear. **Recommend few minor Maintenance Repairs with paint and caulking to prevent entrance of insects.**

Paint

Caulk

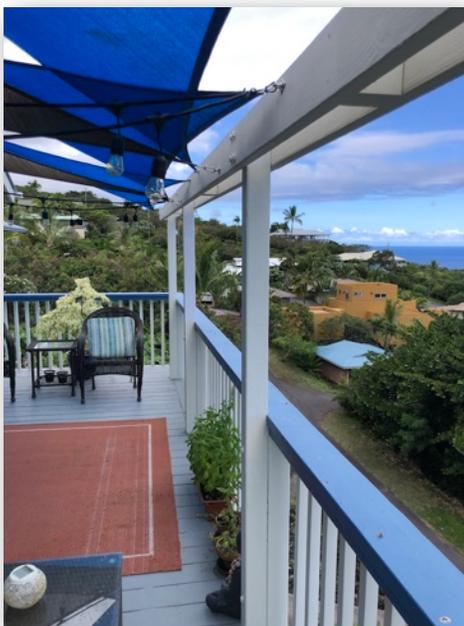
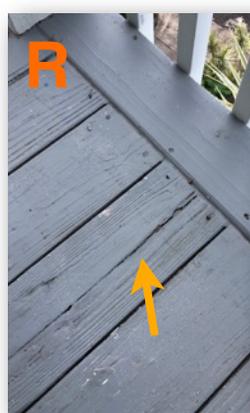
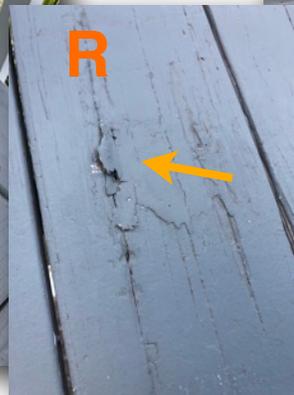
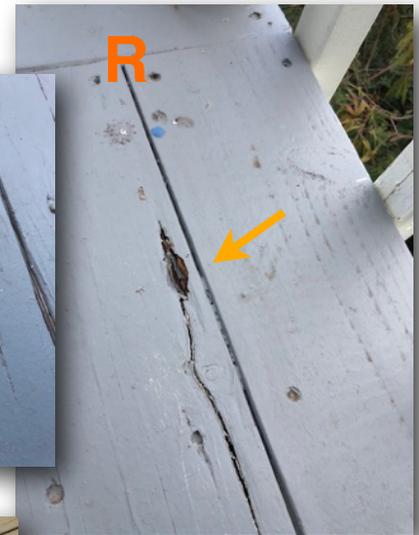
**Comments:** The Lanai was recently covered in shade cloth. Hi-Bor wood products are good to prevent insect damage, however Hi-Bor is not a guarantee against damage from continuous sun and moisture. The Lanai deck boards have small areas of deterioration - Mostly at nail heads, previous repairs and sun cracked wood grain. At the time of inspection there was one small area where the moisture has made its way to the underside of the lanai. **Recommend a qualified carpenter for further evaluation and repair.**

Small areas of Deck board deterioration

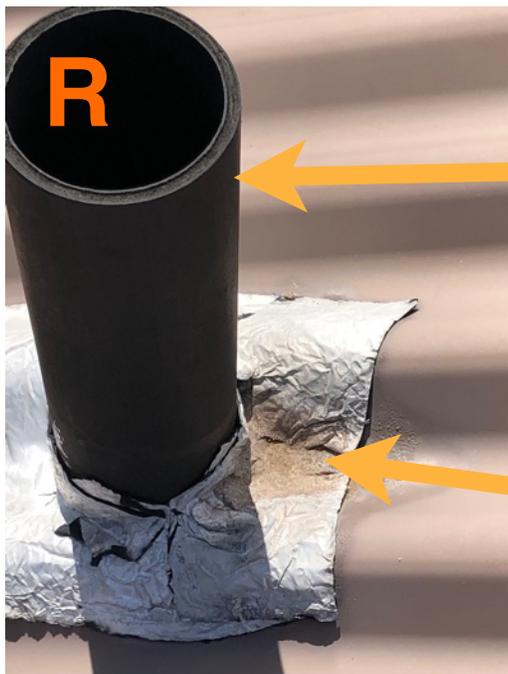
Spray Paint needed

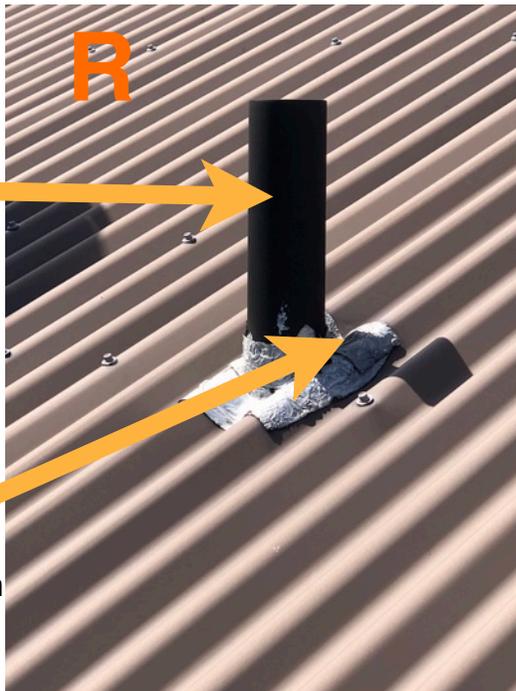
Water Collects in pocket: Re-flash with diverter

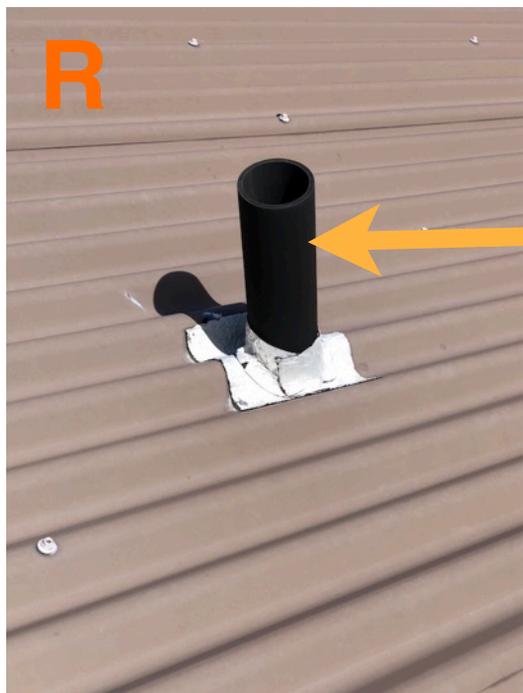
Spray Paint needed

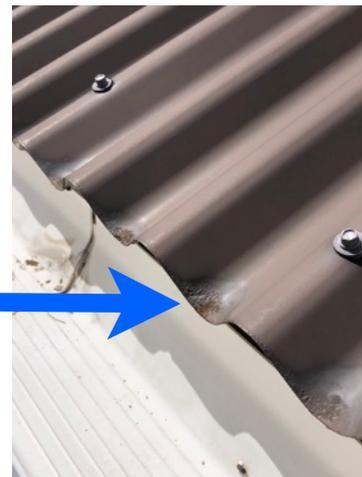
Minor Rust Creep: Monitor

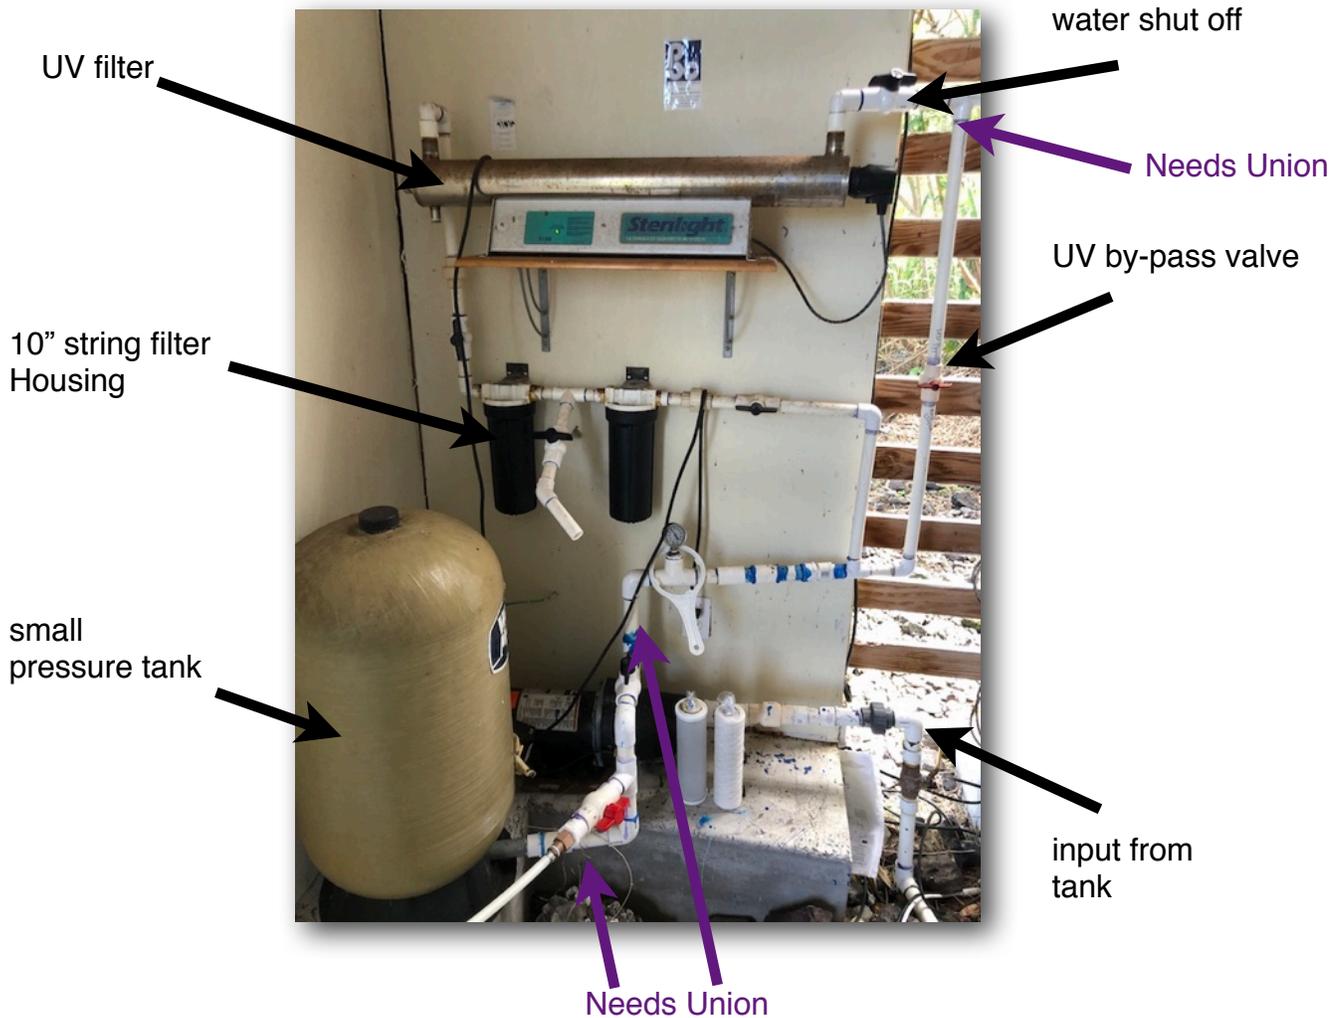
The system is missing several unions for servicing components. Without unions in key places the pipes need to be cut to replace the Pressure Tank, Pump, or UV filter.

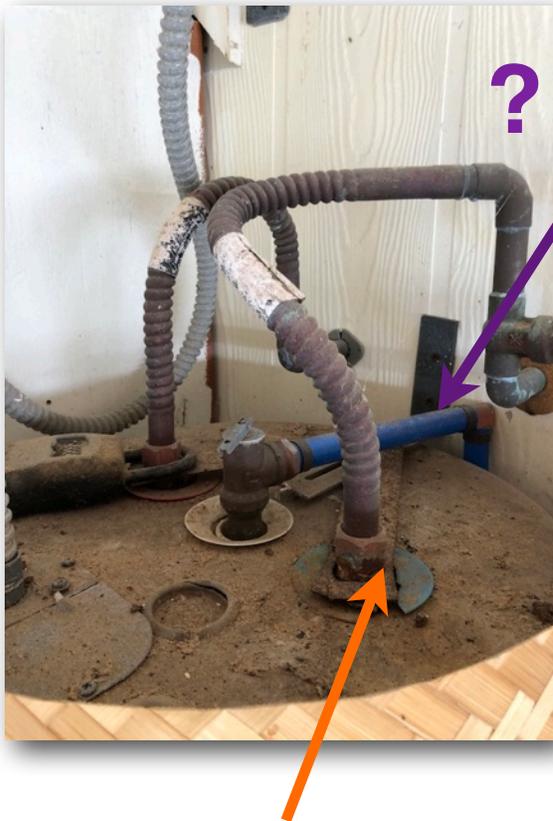
TPR - Temp/Pressure Relief Valve piping is PEX. Should be copper or CPVC. TPR drains behind the tank. It should drain outdoors.

**Potential Leak:** Cold water inlet pipe nipple on water heater is heavily rusted

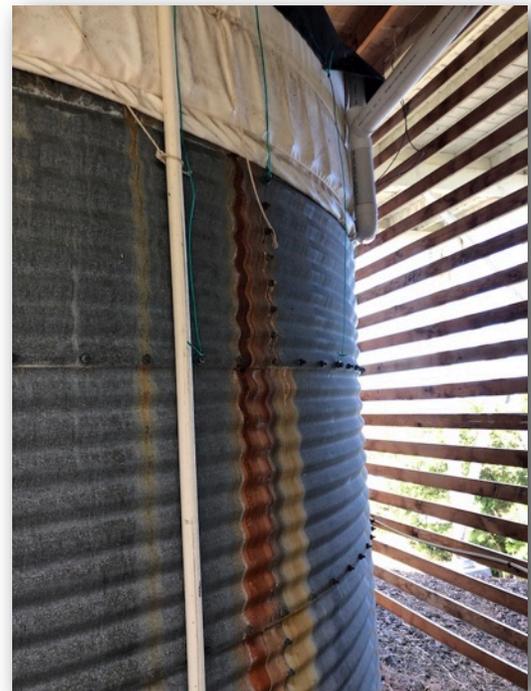
Minor Rusting on the water tank. Typical from poorly functioning overflow

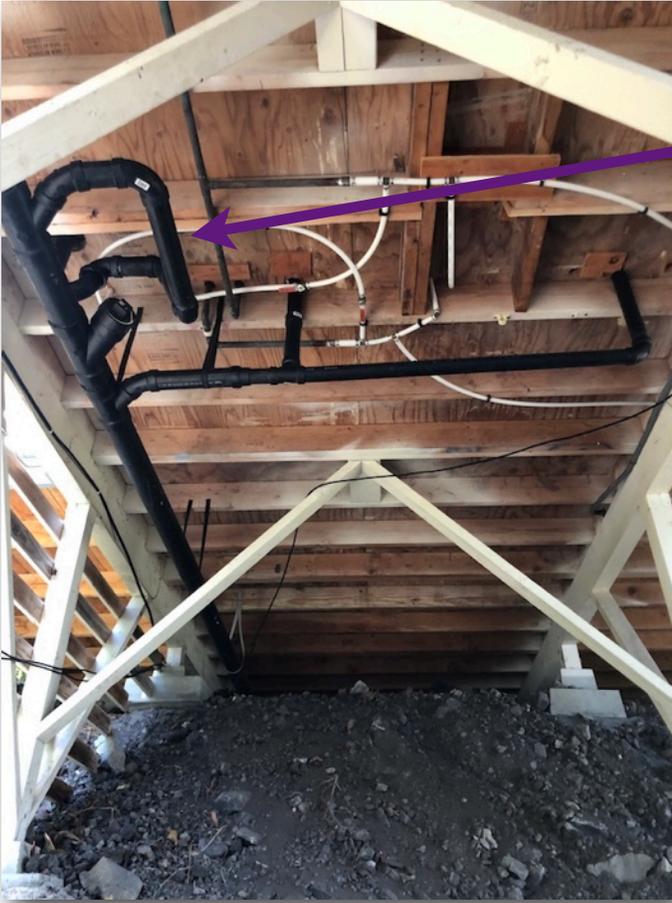
The shower drain is missing vent after Trap. Without a vent, water can be pulled or gurgled from the shower trap allowing sewer gas smell to enter bathroom. I recommend an UPDATE by a qualified plumber.

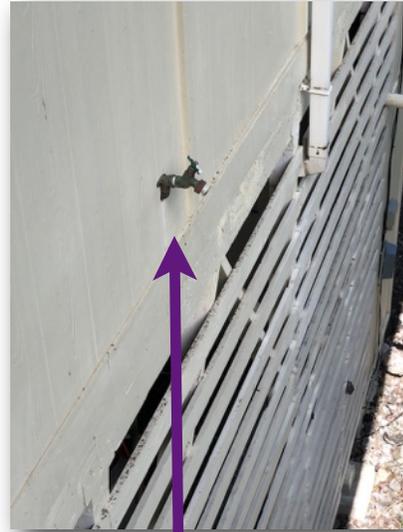
Hose Bib inaccessible from ground

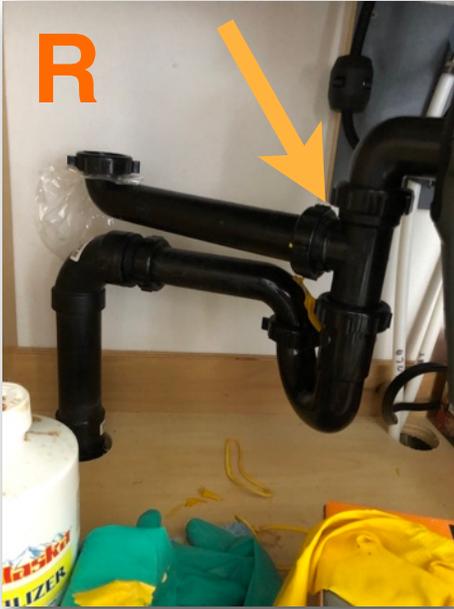
The sink installed is single bowl with disposal, yet there is an extra drain for a double bowl sink that could leak during a clog and cause damage. The T joint can be removed and an extension tailstock installed.

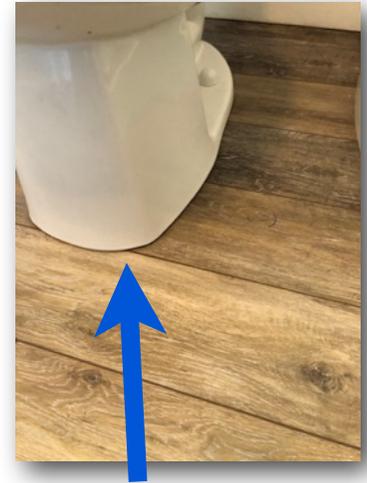
Toilet Base could be sealed to prevent moisture going under base and to provide stabilization.

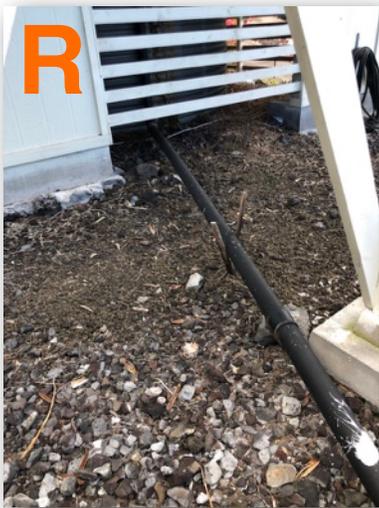
This 3" pipe is for filling the catchment tank in times of low water from a water truck on the street. The pipe span is largely unsupported, balanced on rocks and pipe could break during an emergency fill.

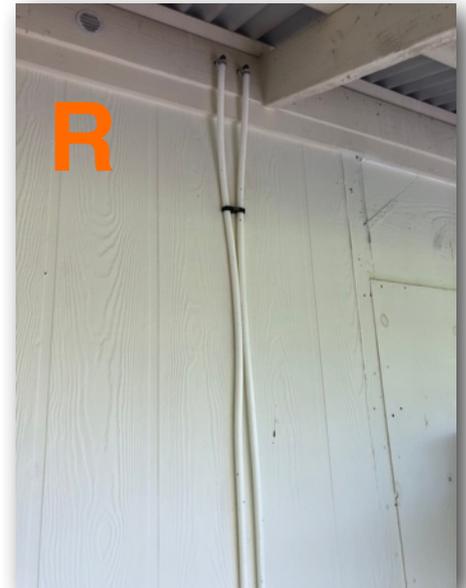
PEX piping on exterior for the outdoor shower could be painted for UV protection.

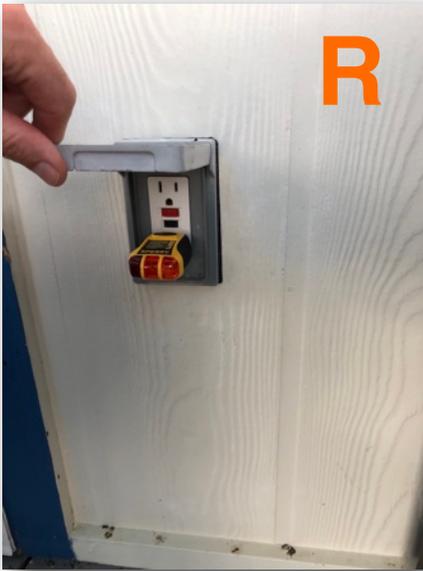
Lanai GFCI outlet with no power

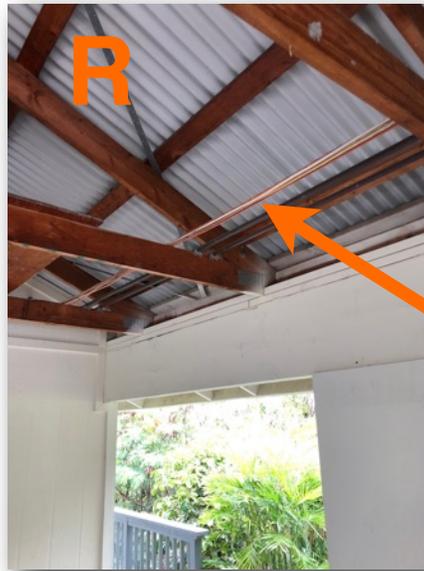
Unsupported wires crossing carport trusses

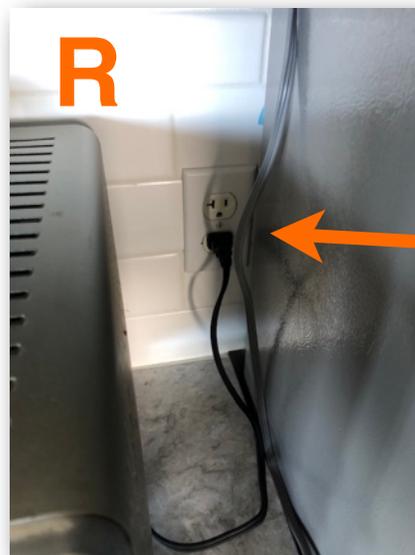
Kitchen countertop outlet is not GFCI protected

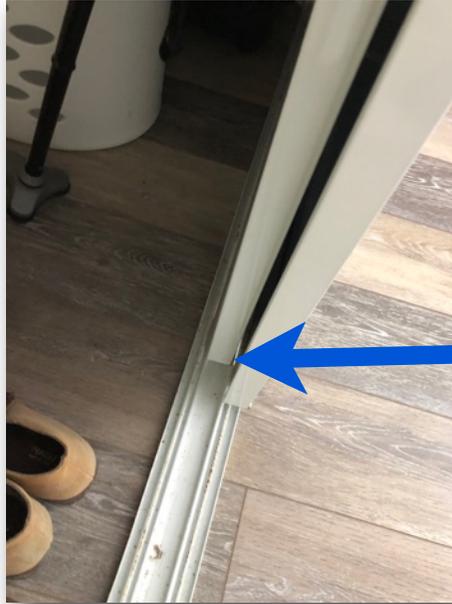
**Comments:** Overall condition of the accessible closet space was satisfactory with the exception of **the rear bedroom mirrored closet door is jammed and off its track. It may need a reset and adjustment.**

Adjust Rear door slide

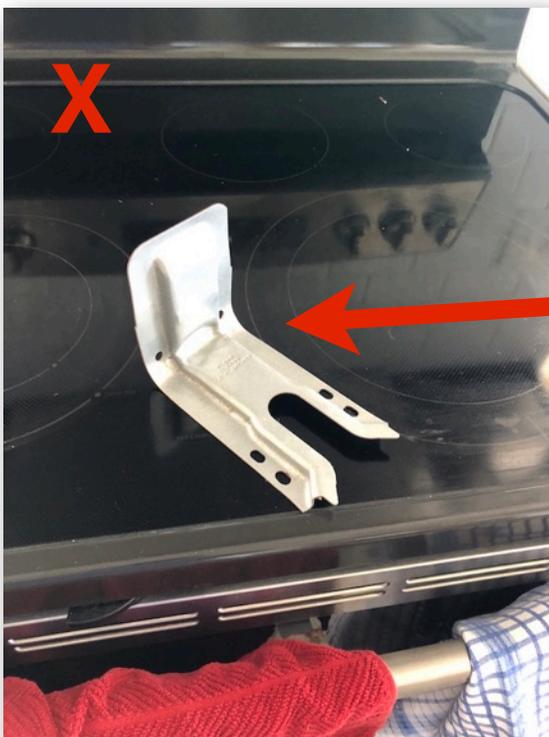
**Anti-Tip safety device**

**The range Anti-Tip safety device was not installed. I recommend this simple device be installed for safety.**

Device was found and remains in the bottom drawer of Range

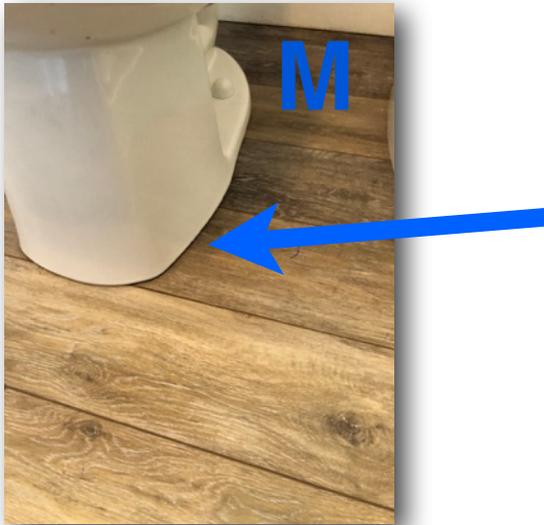
Toilet could be caulked for stabilization and prevention of condensate and water entering under the toilet and damaging the wood understructure
