**HIHI Inspections**  
HAWAII ISLAND HOME INSPECTIONS

**Inspection Address**  
12-12345 Street St.  
Hawaii Town, HI 96000

**Inspection Date**  
May 24, 2023  
10:00 am

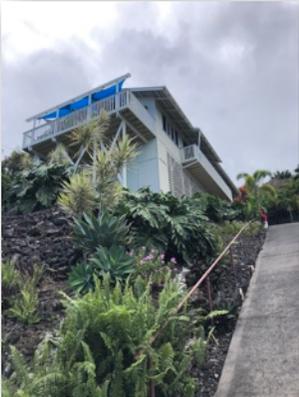
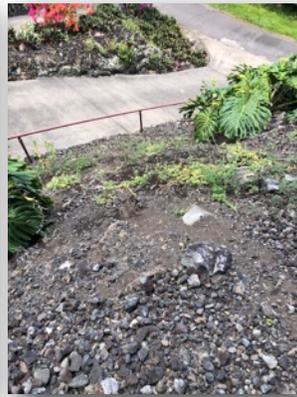
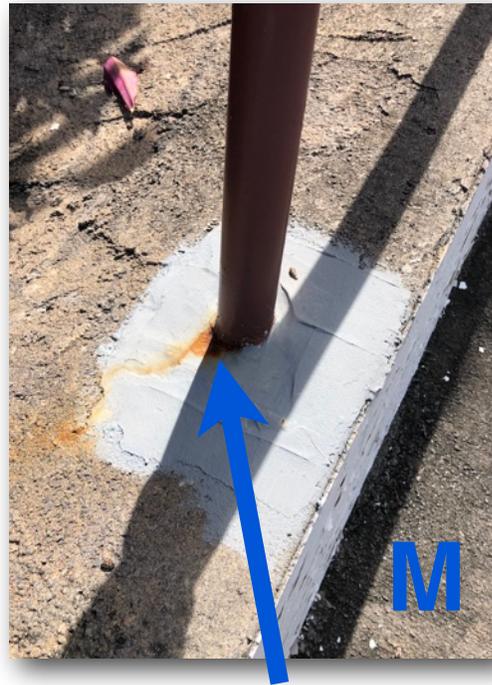
Minor Maintenance: Paint and exterior caulk

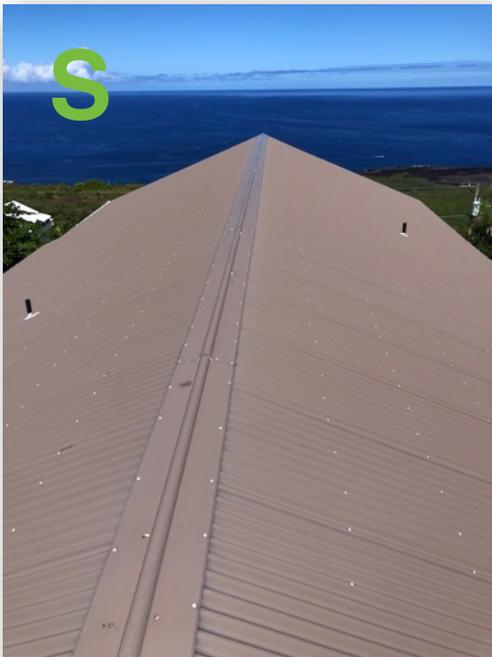
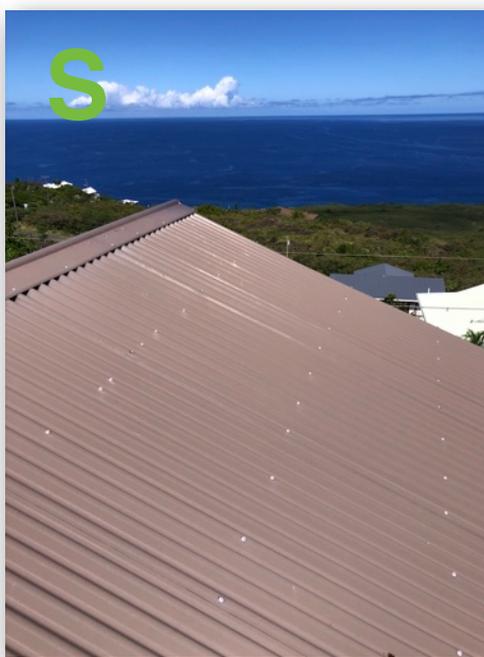
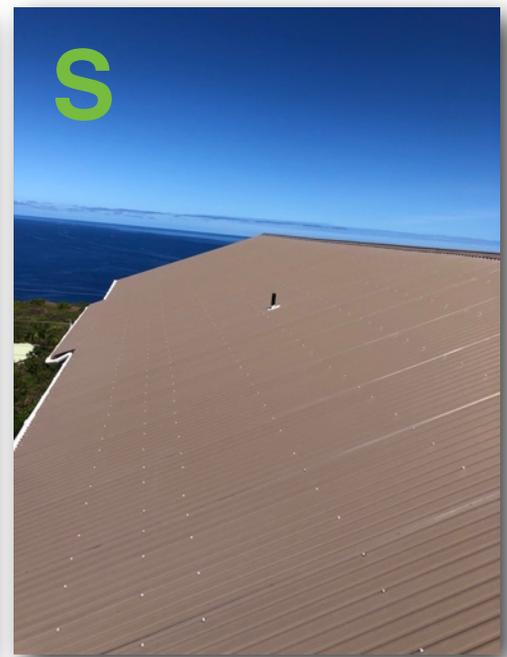
The **Gutters** are plastic and are in fair condition with proper hanger angles and plenty of support. There is vegetation clogging the north side downspout entrance which can cause overflow onto the fascia boards. There is also a point above the walkway that looks as though its a pinch point that can not handle the volume of water in a medium to strong downpour - because there is only one collection downspout per side. A baffle may help, but it is not crucial.

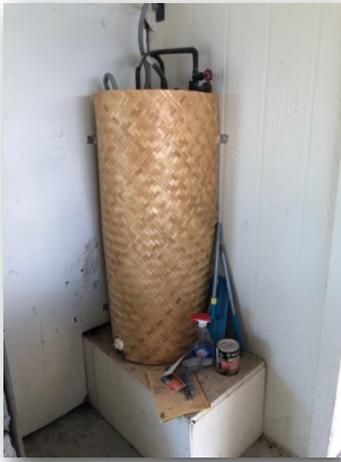
30 gal 240volt tank

**Hot Water Tank:** Located in Carport. The 30 gallon hot water tank is from 2008 - 13 years old - past its servicable life expectancy. It is showing indications that it may need replacing. I recommend further evaluation by a qualified plumber.

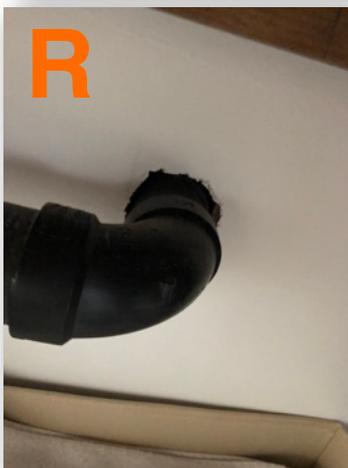
Bath vanity wall drain penetration needs escutcheon or seal to prevent air flow and critters

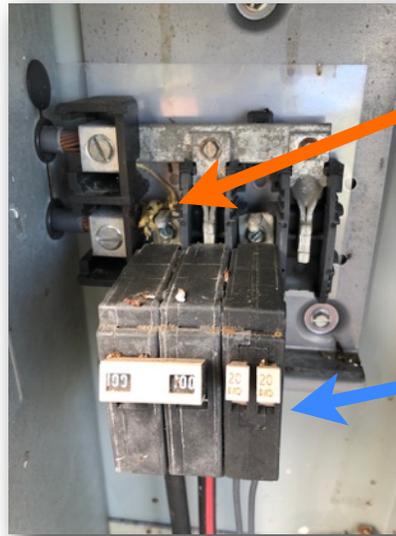
**Comments:** The Main Disconnect Panel has some oxidization on its bus bars from exposure to the exterior salt air. There is some debris and possible cloth wire insulation resting on one of the power leads from the meter box and an unknown wire tap. The Water Pump and UV filter both have breakers in this box.

Wire insulation debris and attachment from unknown wire

**Reccomend:** With the other recommended repairs by a qualified electrician, I recommend that the Main Panel be checked for corrosion, the unknown wire (possible tap) and debris.

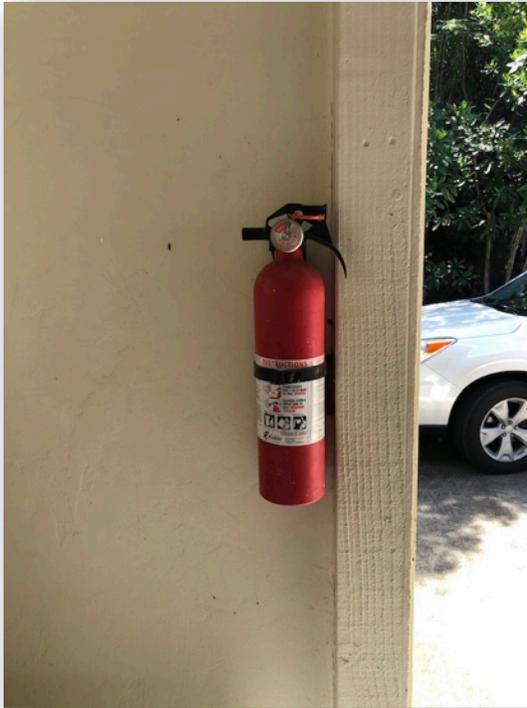
Fire Extinguisher in Carport

**It is also noted that a fire extinguisher** was found in the Carport near the laundry machine. Its age and functionality are unknown.

It is recommended to have a least one appropriate fire extinguisher within the house as well. All fire extinguishers should be periodically replaced per manufacturer's guidelines.

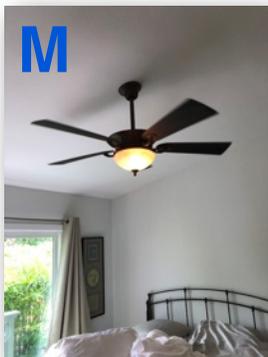
**Comments:** All fans, lights and remotes were tested and functioning with the **exception of the Rear Bedroom fan blade balance. There is a wobble in the fan spin that indicates an unbalanced blade(s).**

Wobble in bedroom fan

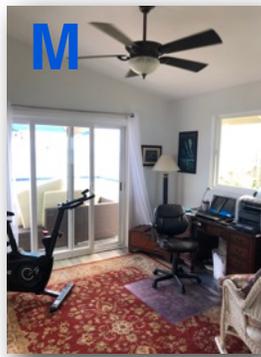
**Comments:** The overall condition of interior doors was satisfactory with typical wear. The Lanai sliders and screens functioned well with the **Front Sliding Glass Door to the lanai located in the front bedroom/office being operational, though stiff to open and close. Probably due to debris and non-usage. Needs cleaning and adjustment. The Front Bedroom/Office Door needs a door stop to keep from damaging the wood sliding door.**

Front Slider needs track adjustment

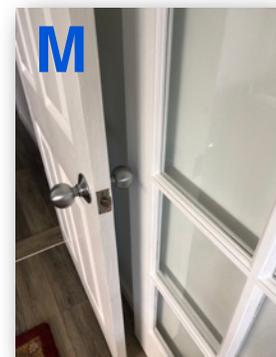
Door stop needed

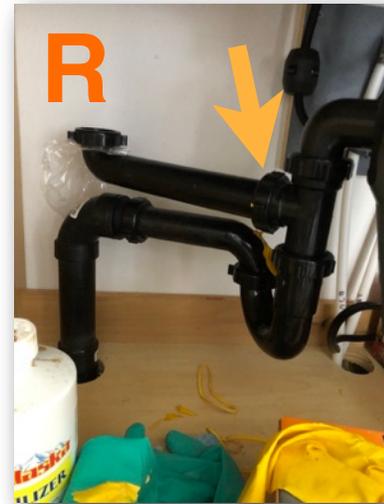
The sink installed is single bowl with disposal, yet there is an extra drain for a double bowl sink that could leak during a clog and cause damage. The T joint can be removed and an extension tailstock installed.

**Comments:** The overall condition of sink was good. The Disposal functioned well, though the switch is far to the left. **The sink drain from the disposal is plumbed for a double bowl. See Plumbing Section for REPAIR.**

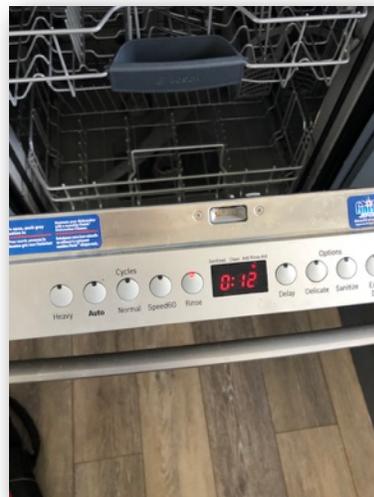
**Comments:** The dishwasher was operated through a short cycle and drained. Noted to be in good function condition, with the EXCEPTION of: **There was no accessible AIR GAP above or below the counter at the time of inspection. I recommend an air gap to be installed.**

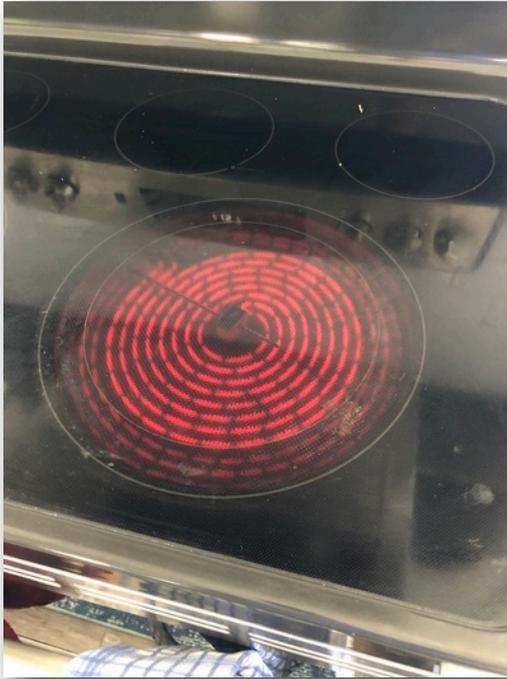
**The range Anti-Tip safety device was not installed. I recommend this simple device be installed for safety.**

Device was found and remains in the bottom drawer of Range
