**HIHI Inspections**  
HAWAII ISLAND HOME INSPECTIONS

**Inspection Address**  
Condo Building, unit 000  
12345 Island St.  
Hawaii County, HI

**Inspection Date**  
June 10, 2023  
3:00 pm

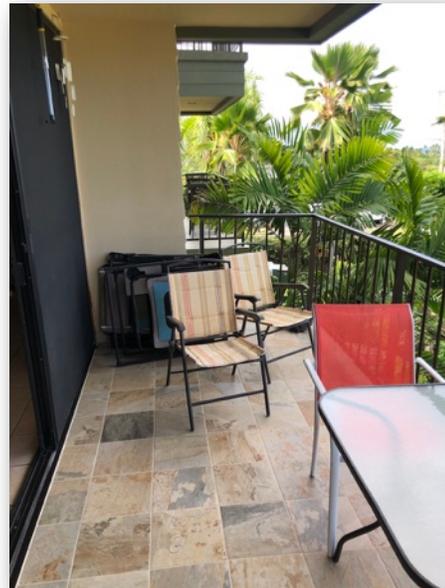
Lanai

2. Facing the condo unit from the Lanai, on the right wall the corner bead and stucco have deteriorated due to water damage, expansion of metal corner bead and the possible pooling of water during heavy rain storms.

Water damage to trim/wall

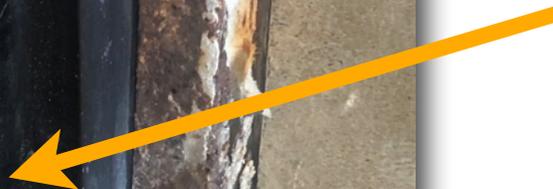
3. In the same area the anodized aluminum door frame has been bent and corroded leaving a gap large enough for rodents, geckos and insects to enter.
4. The anodized aluminum rail is showing signs of corrosion at many fittings.

Corrosion of sliding door and frame - leaving a hole

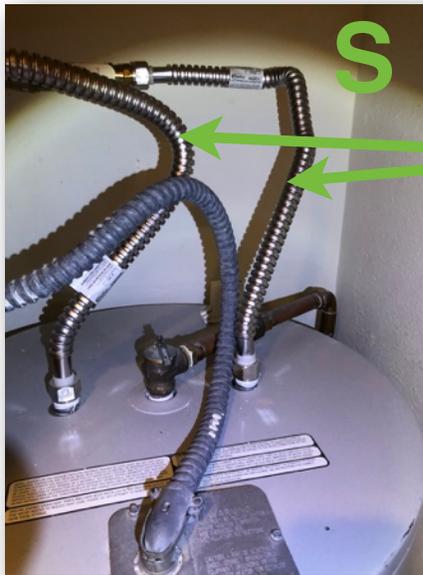
New Flex Hoses installed

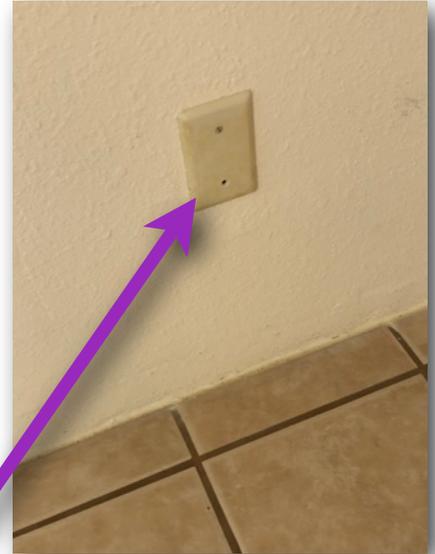
31. Unknown switch in hallway. Labeled as such. Along with at least 5 covered, unused outlet, junction and ceiling fixture boxes indicates a history of electric fixture changes, modifications and repairs.

Unknown Switch

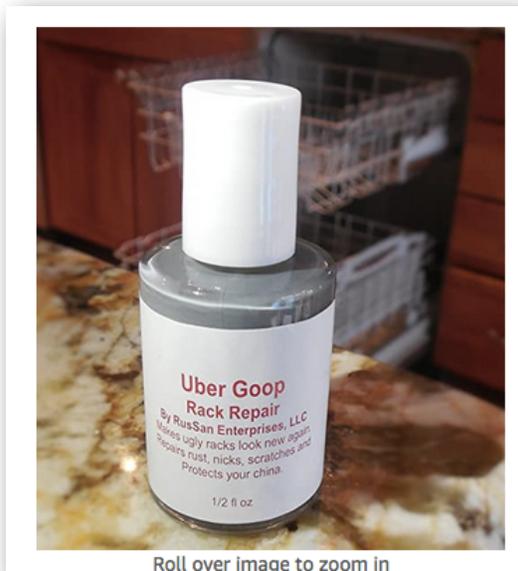
Small Rust Defect in Rack

Rack Repair on Amazon

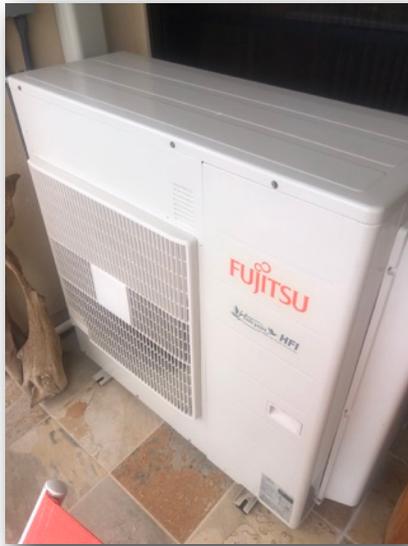
Condenser on Lanai

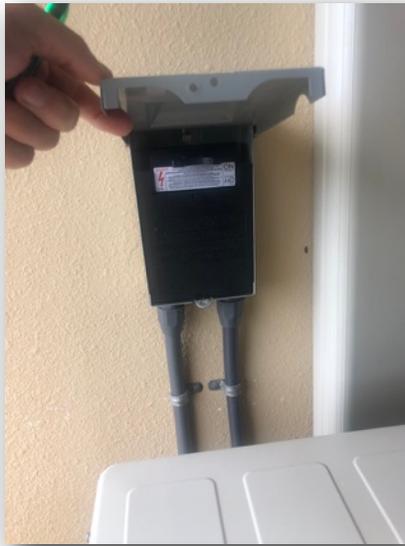
Power disconnect within  
reach

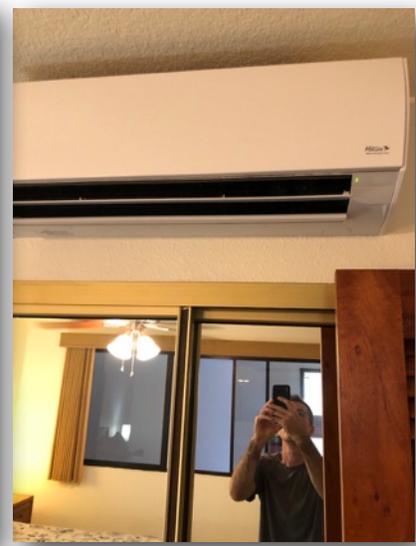
Bedroom wall unit

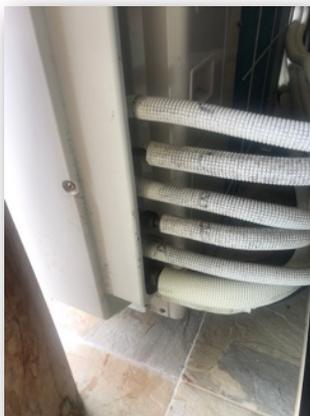
Distribution  
lines labeled  
and free of  
frost

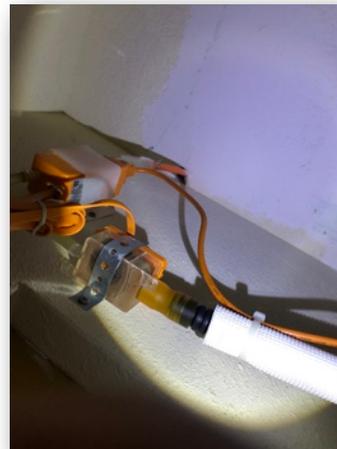
Condensate  
pumps and  
switches in  
Bedroom  
closets
